# Hurricane Sandy

Overview of Subway and Bus preparations,  
impact and recovery  
NYCT Committee Meeting  
November 26, 2012

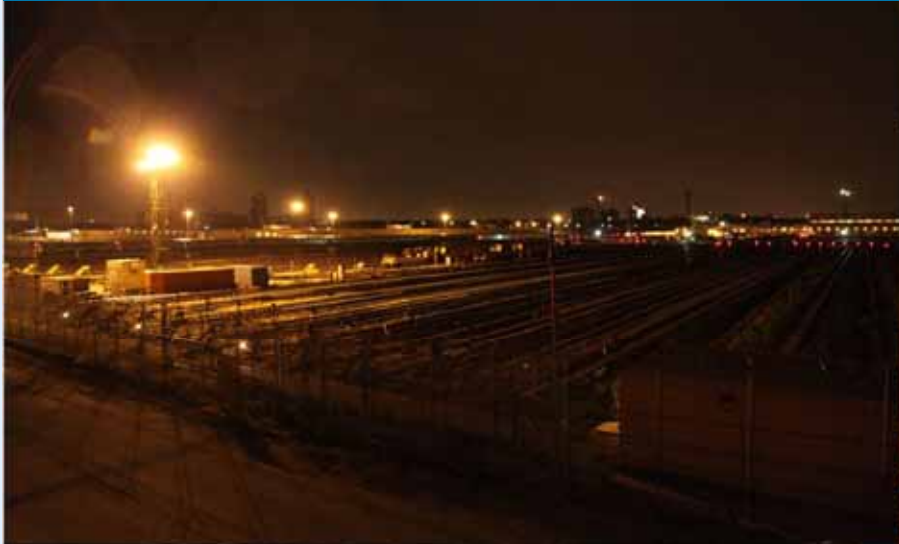
Coney Island Yard

## Storm preparations - subways

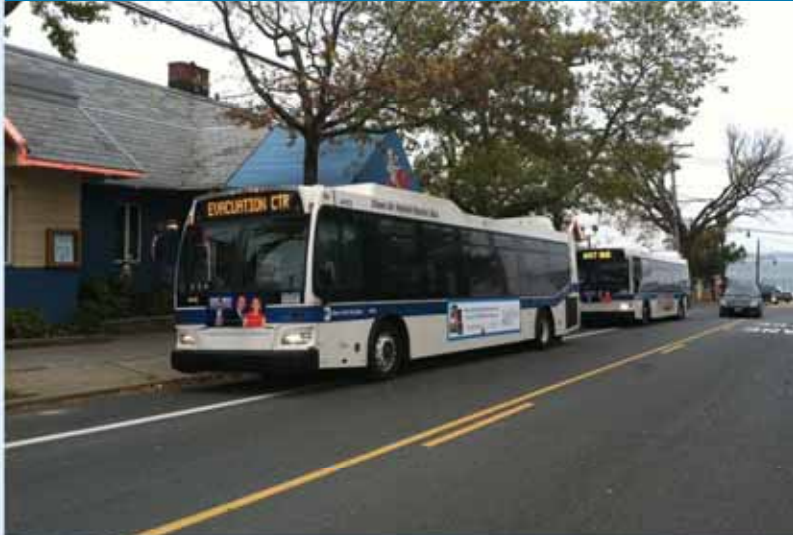
Buses staged for evacuation (City Island)

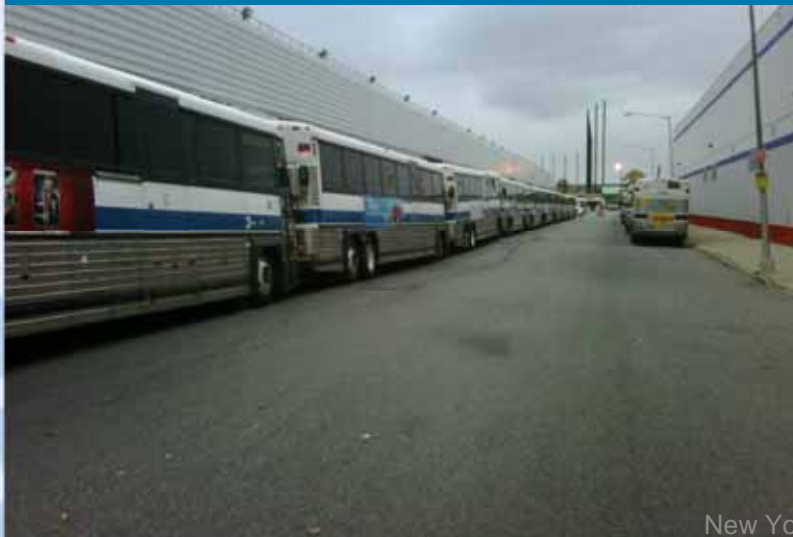
Buses relocated to higher ground (Gun Hill depot)

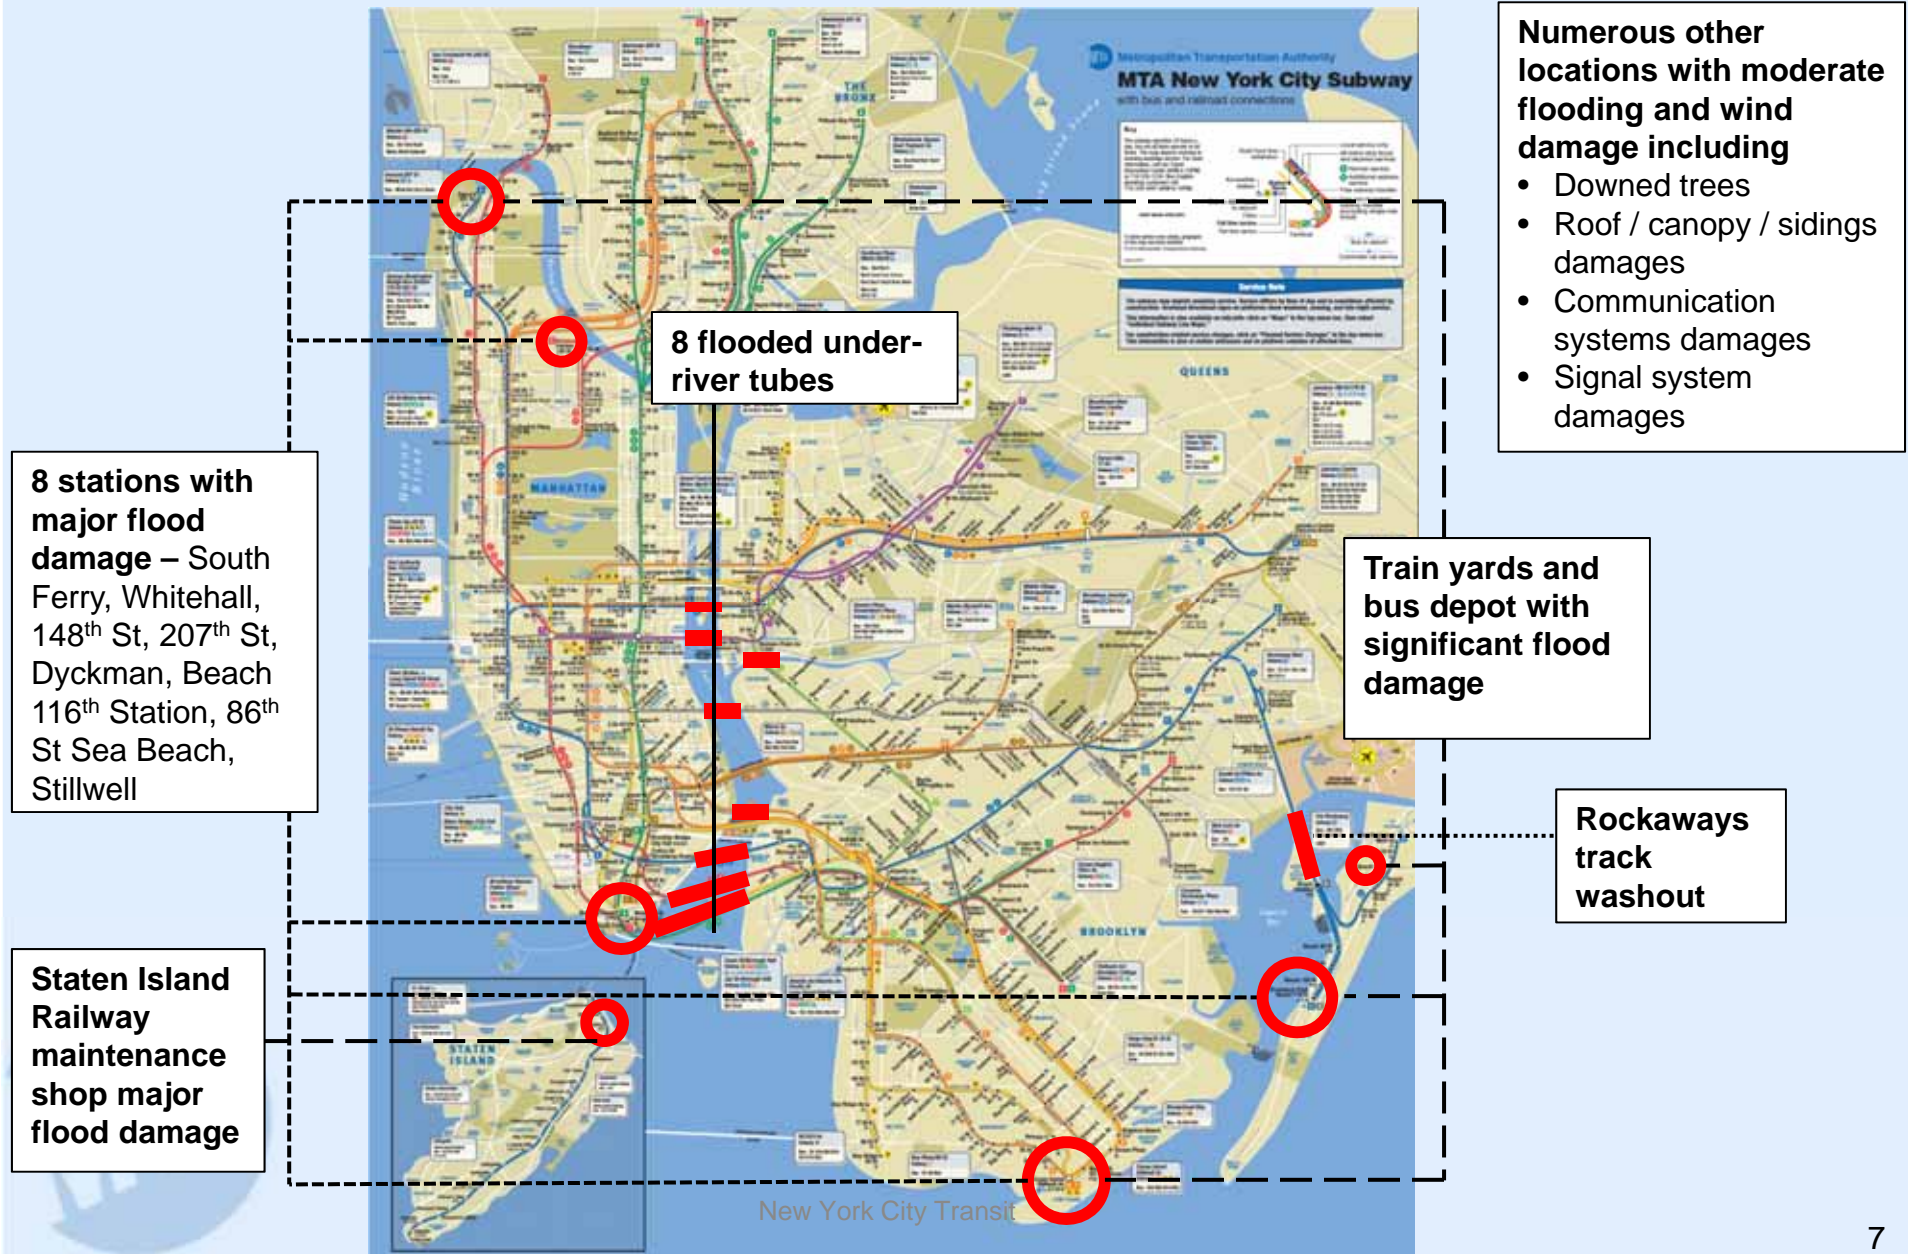
# Sandy caused major flood damage across the system

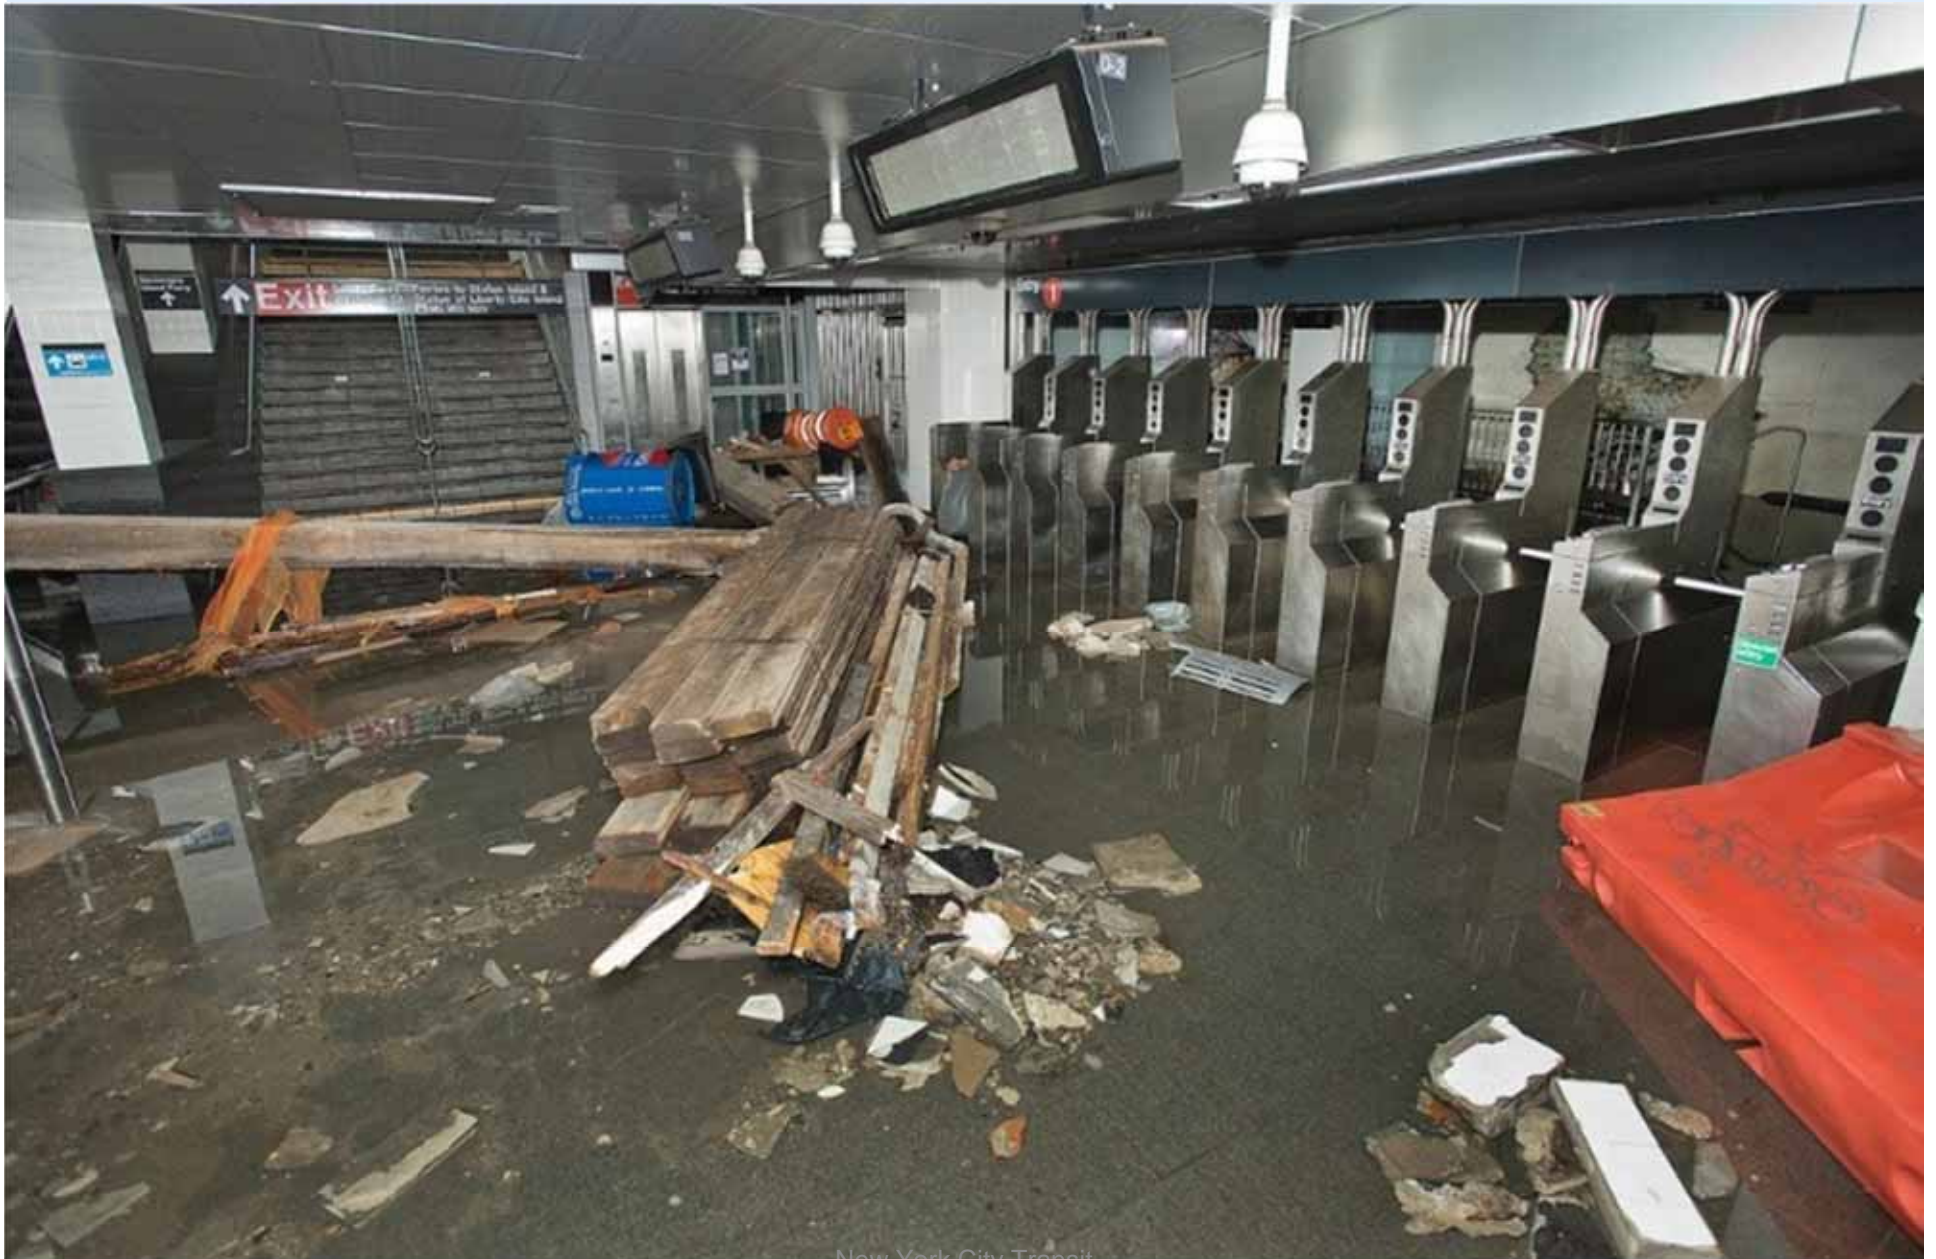
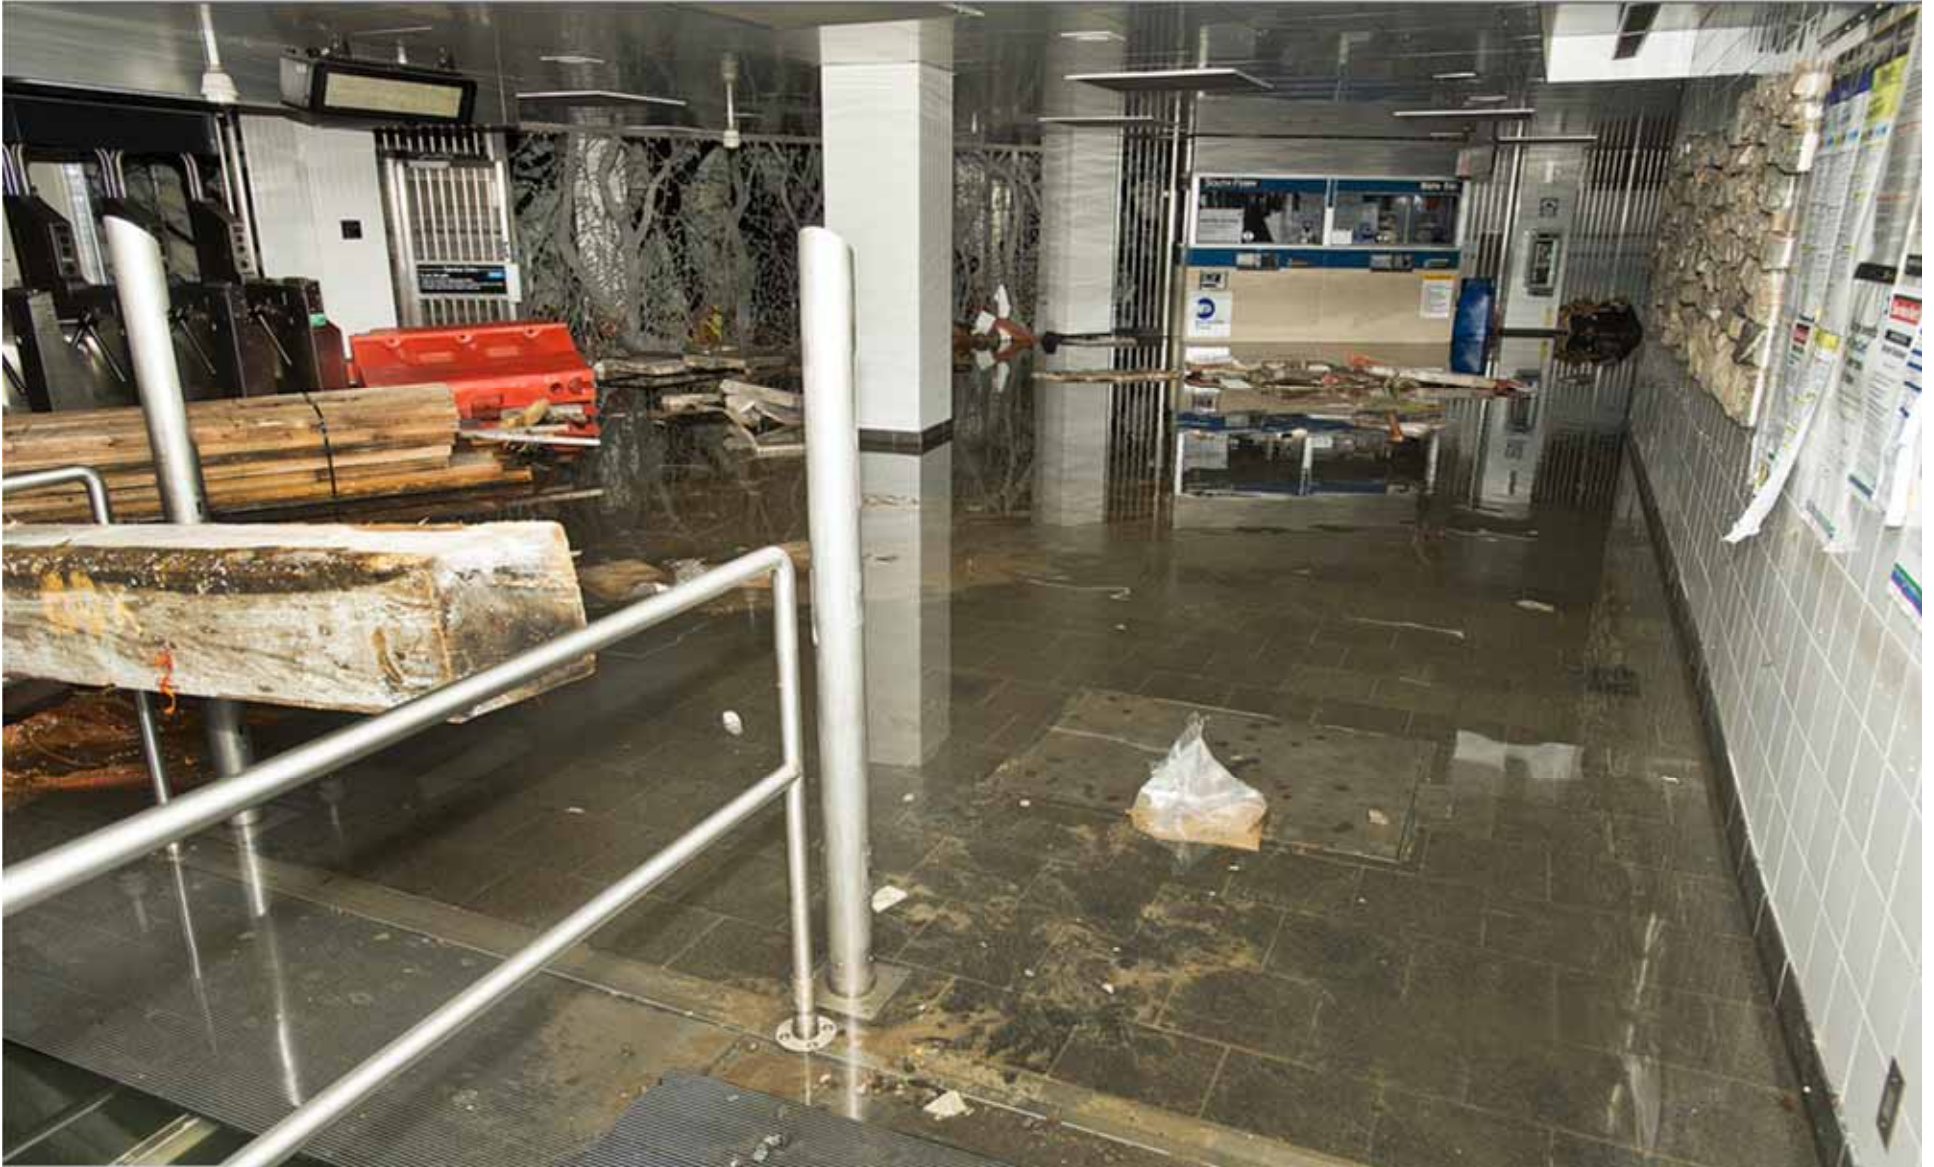
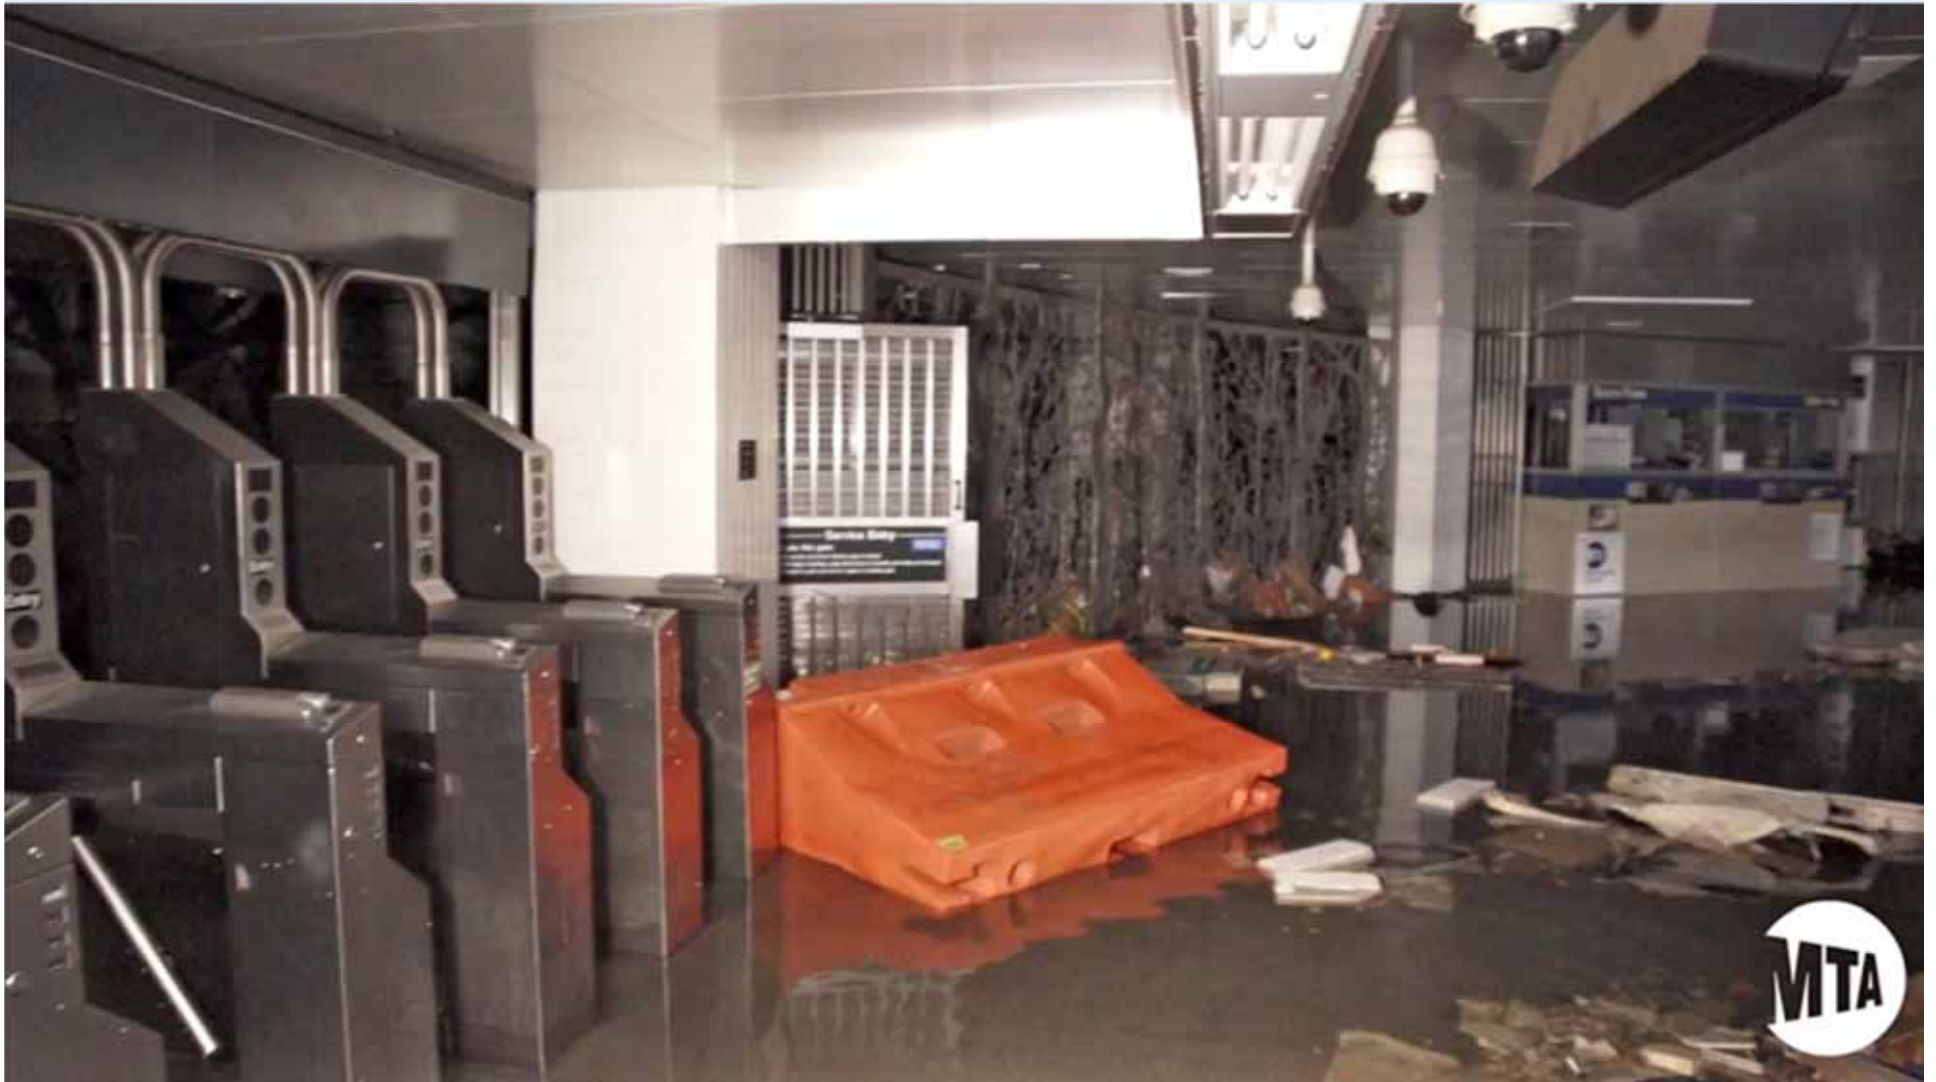
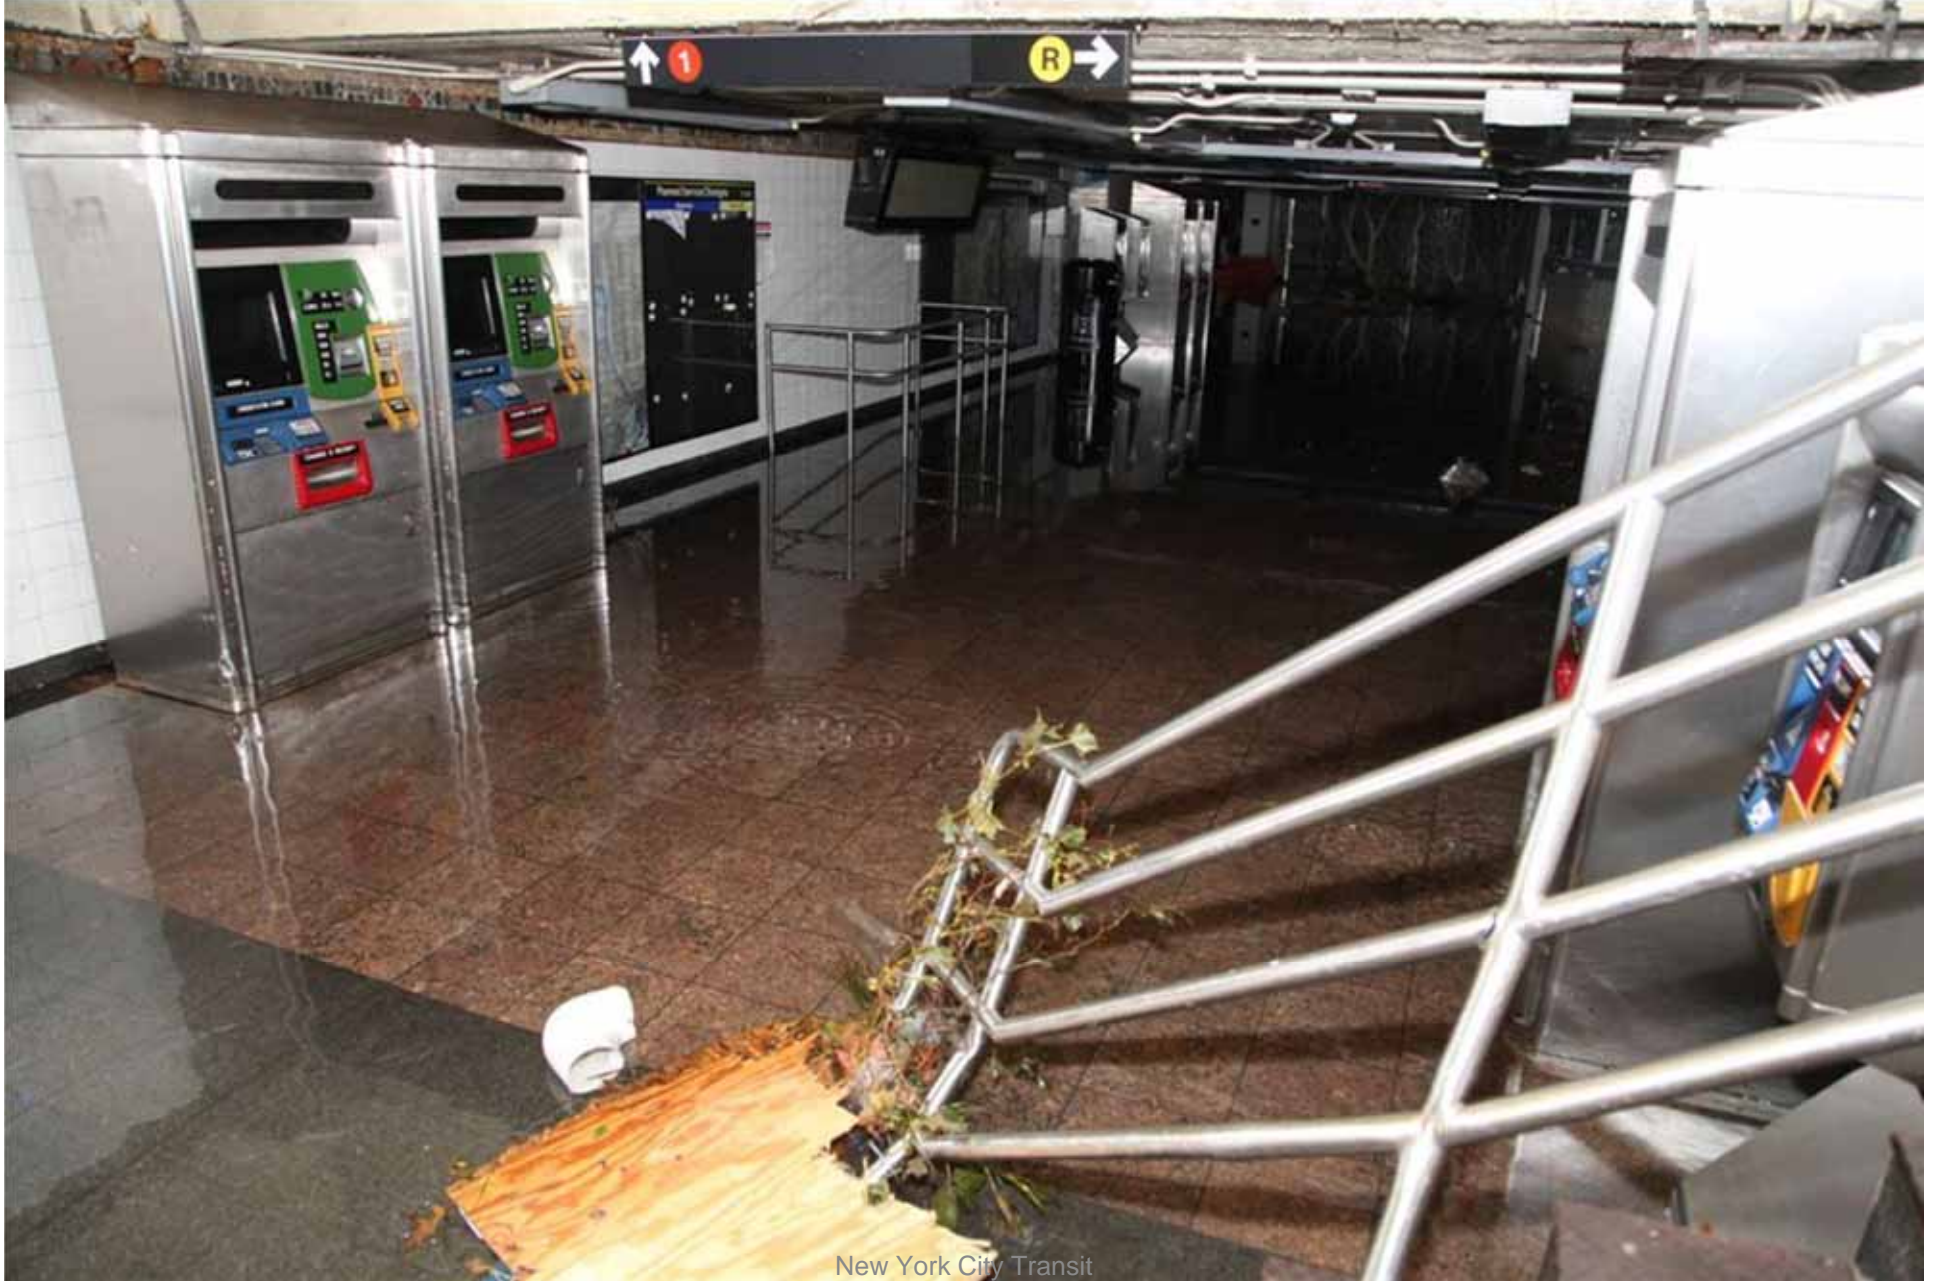
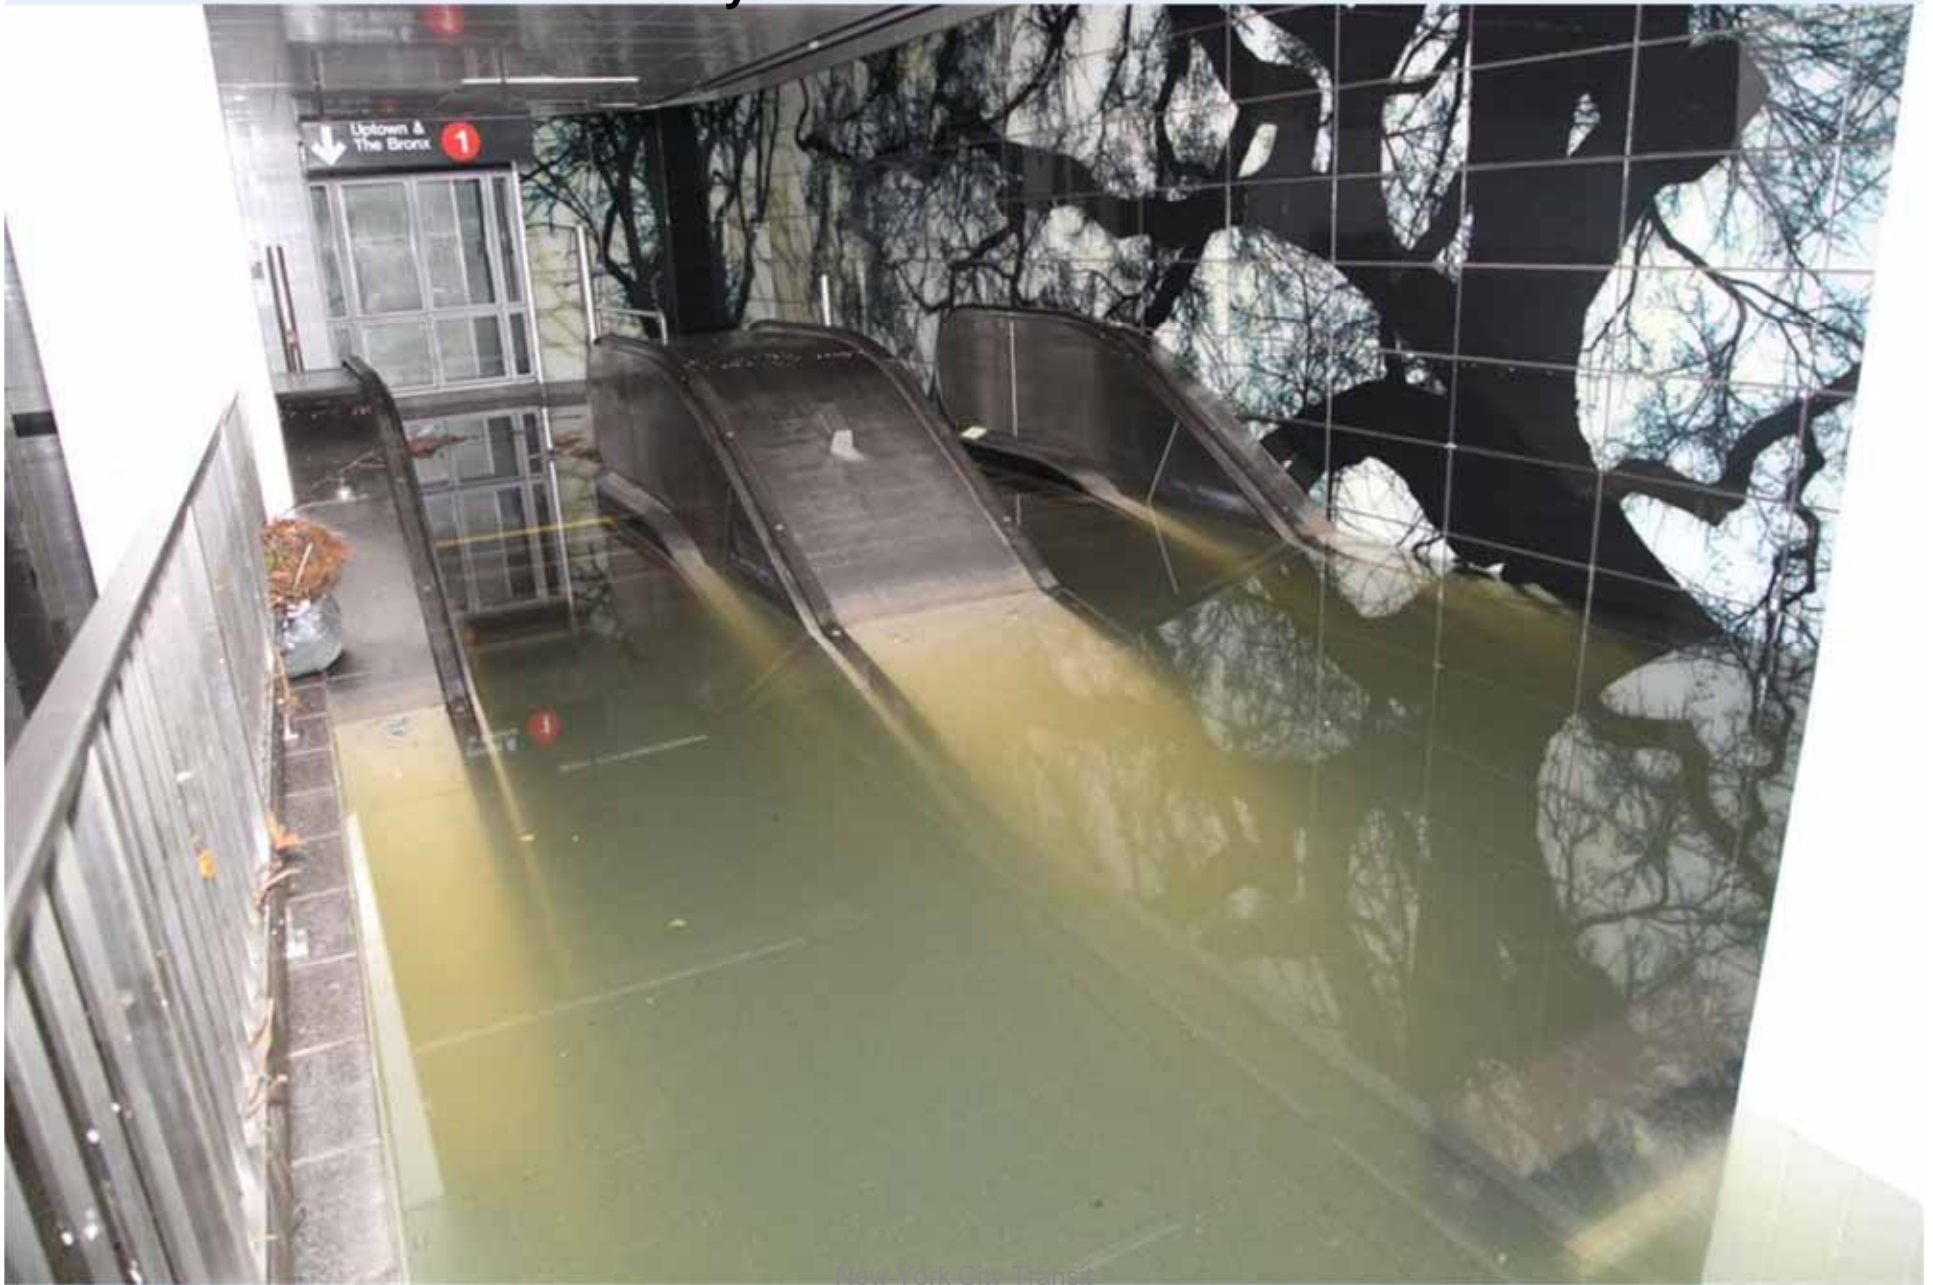
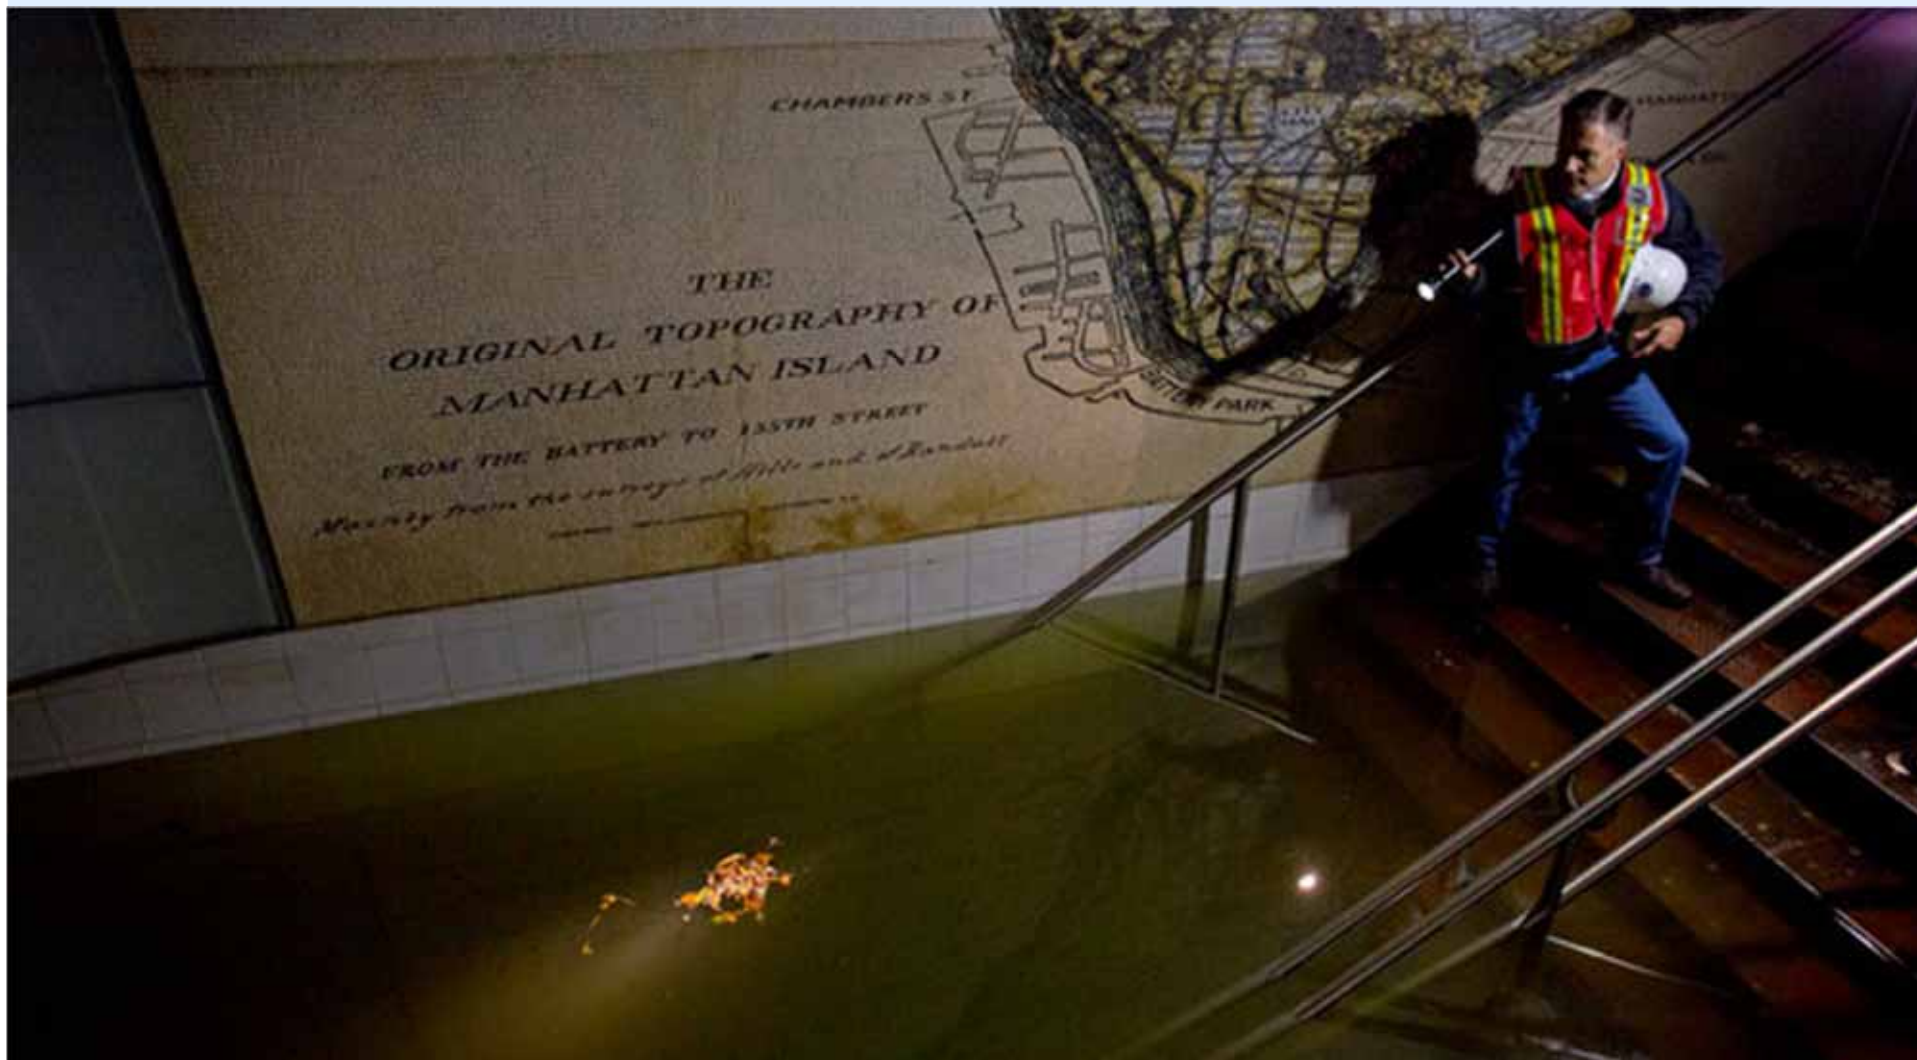
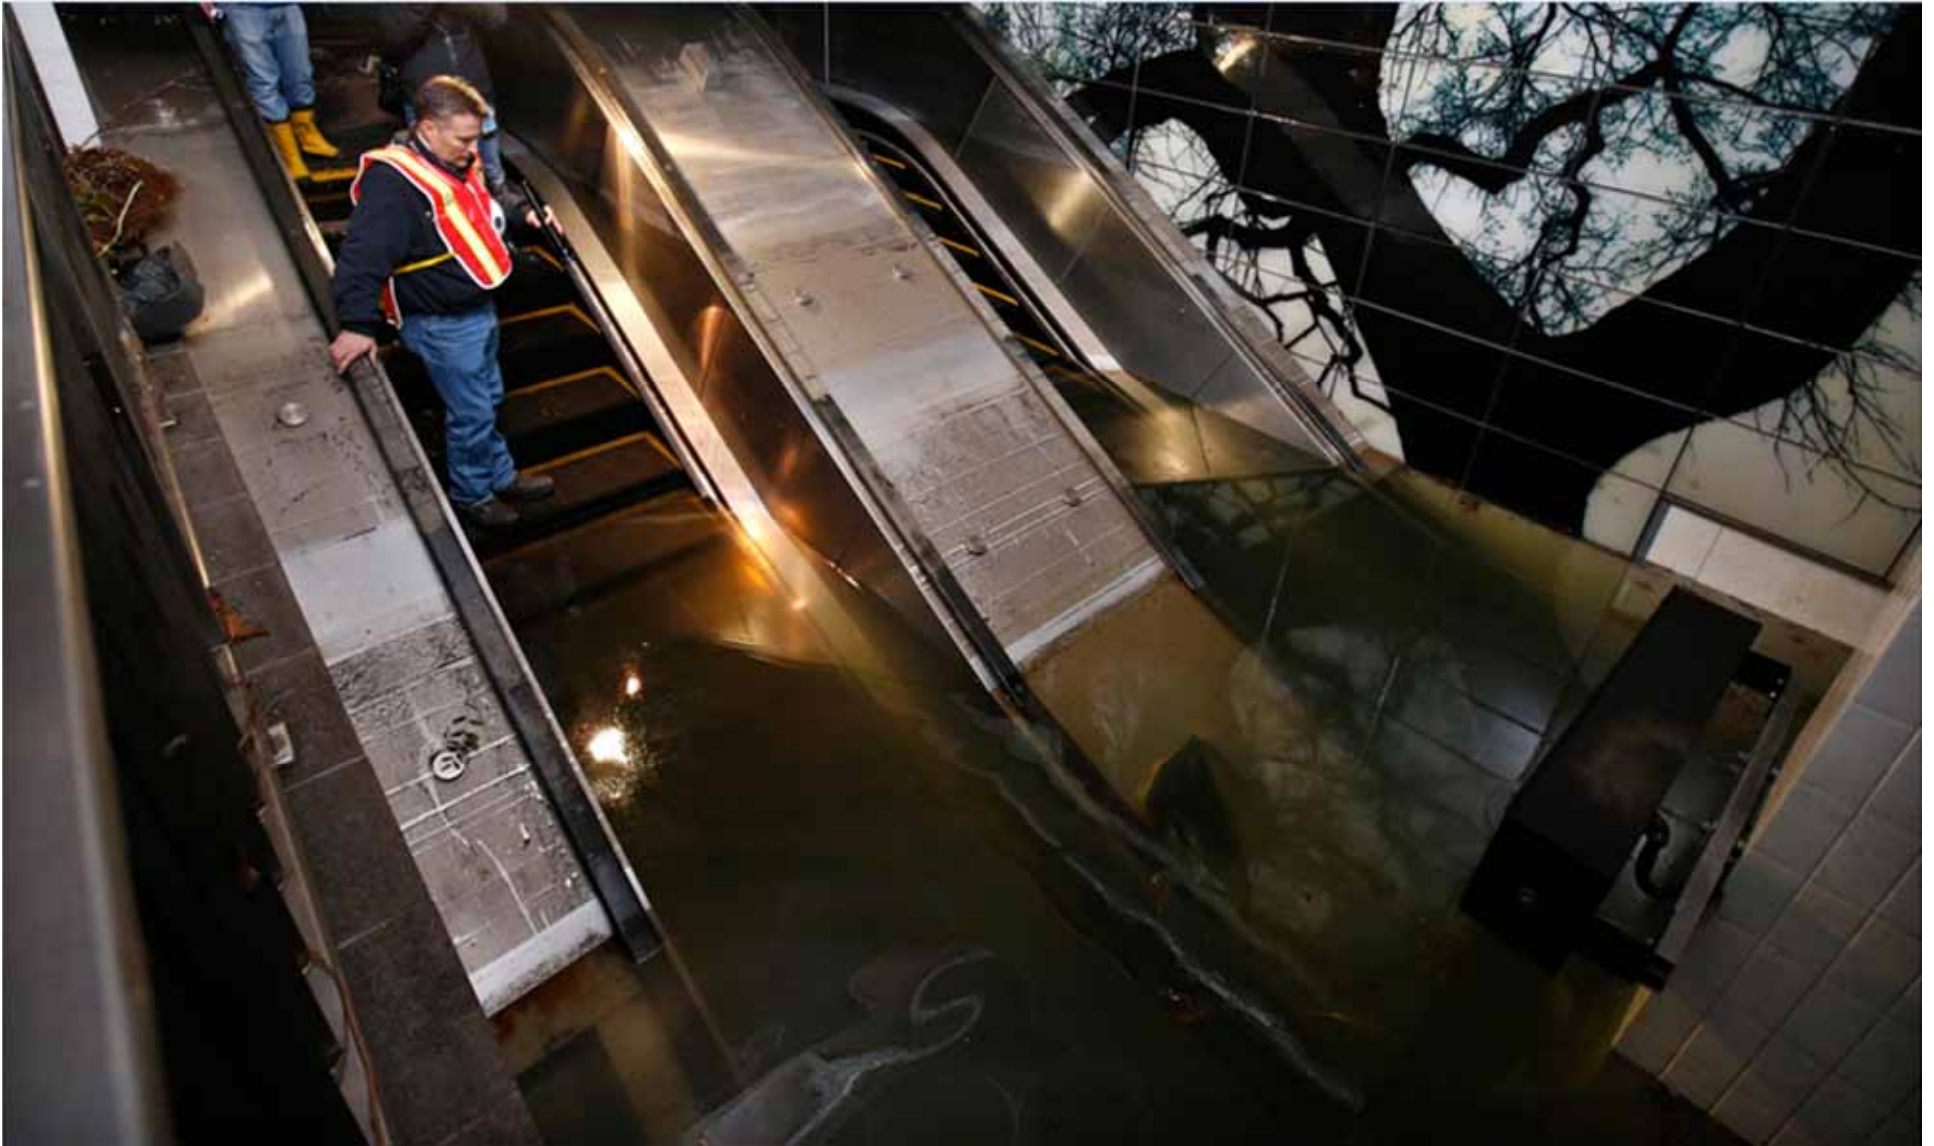
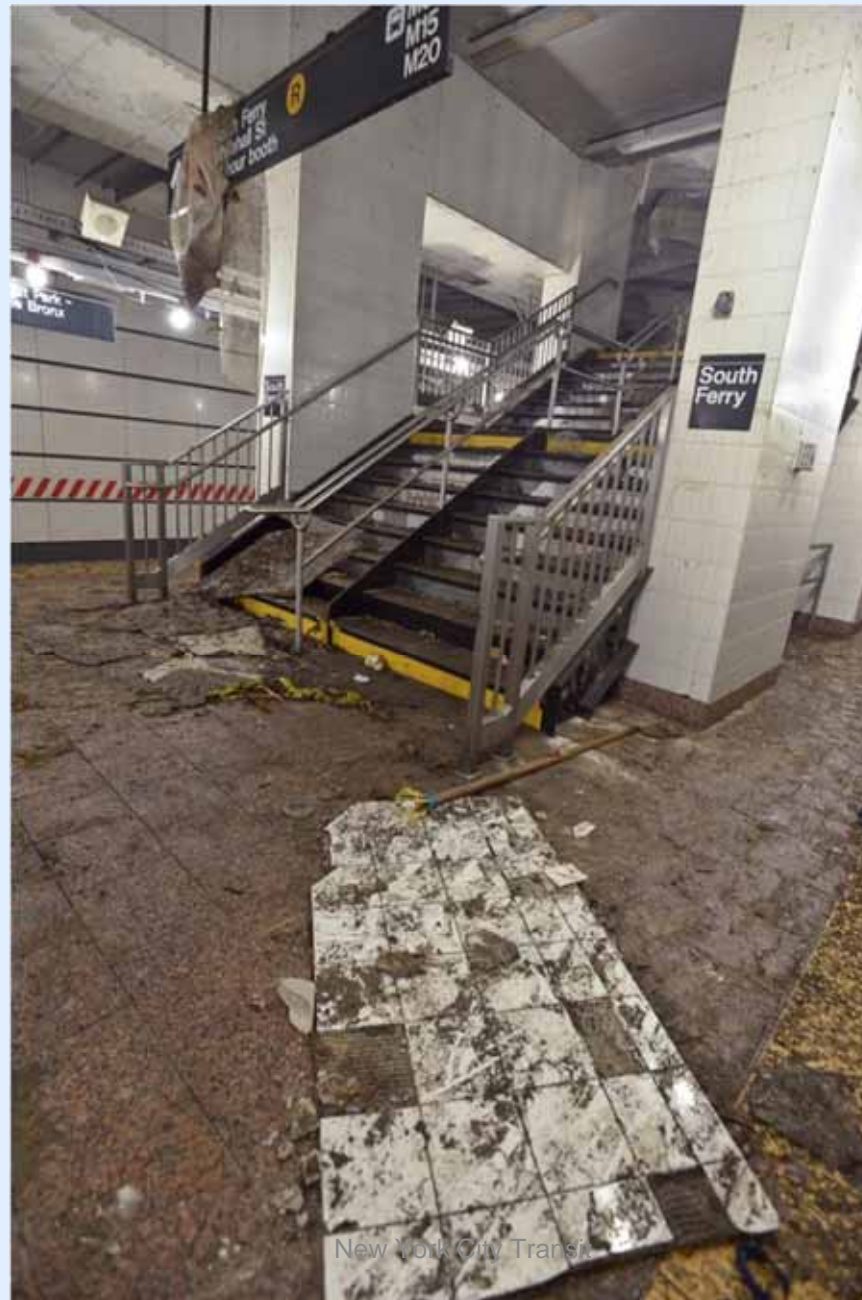
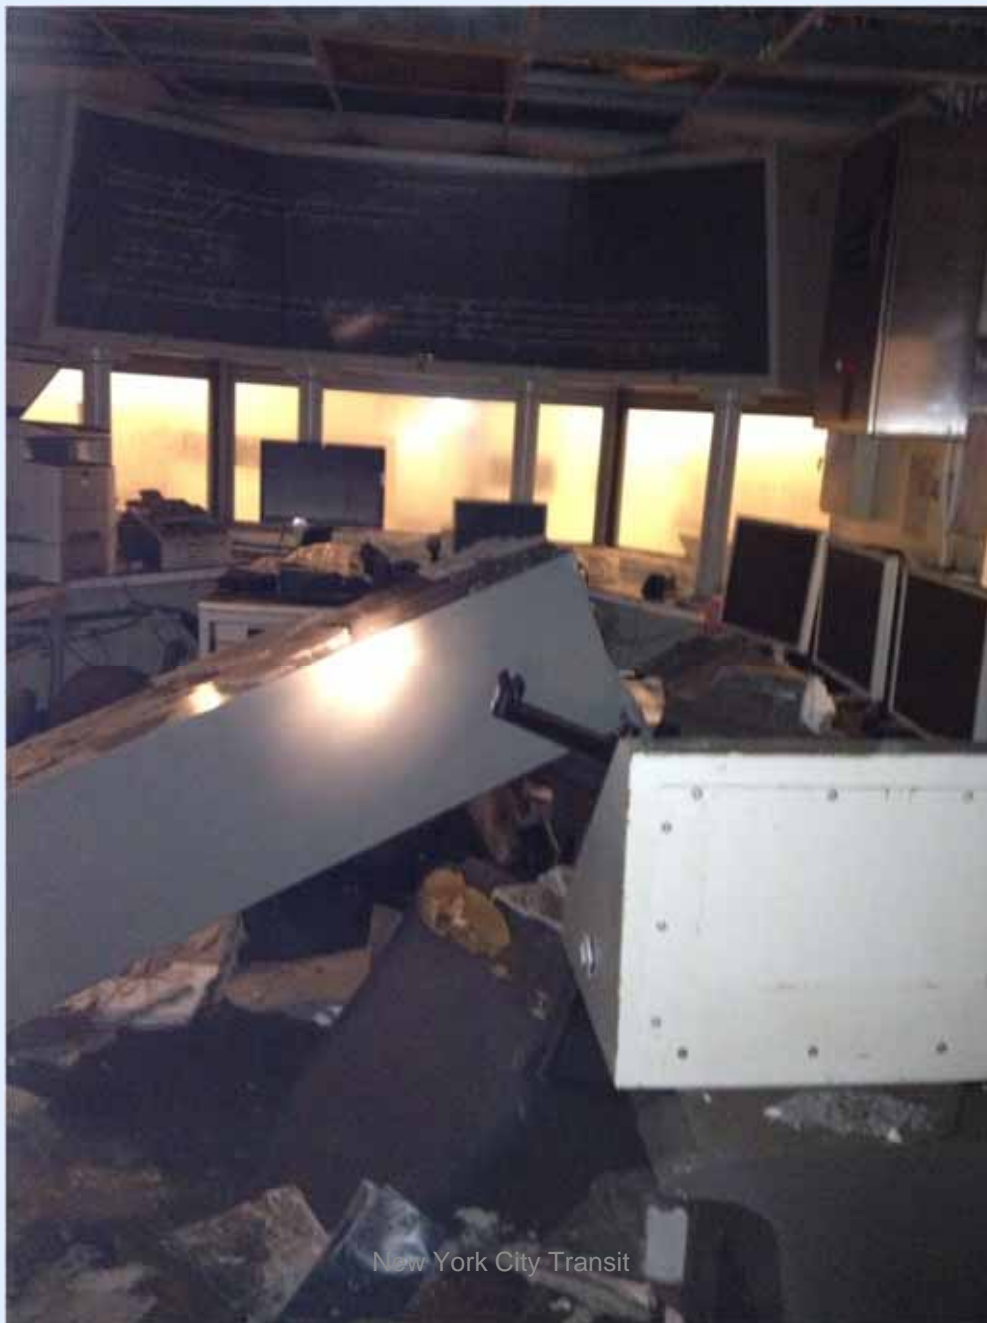
## Flooded stations – South Ferry

- Extensive flood damage to all systems
- Assessment and restoration work ongoing
- **1** operating to/from Rector St at normal frequencies, using the old South Ferry loop to reverse direction
