# Hurricane Sandy

Overview of Subway and Bus preparations,  
impact and recovery  
NYCT Committee Meeting  
November 26, 2012

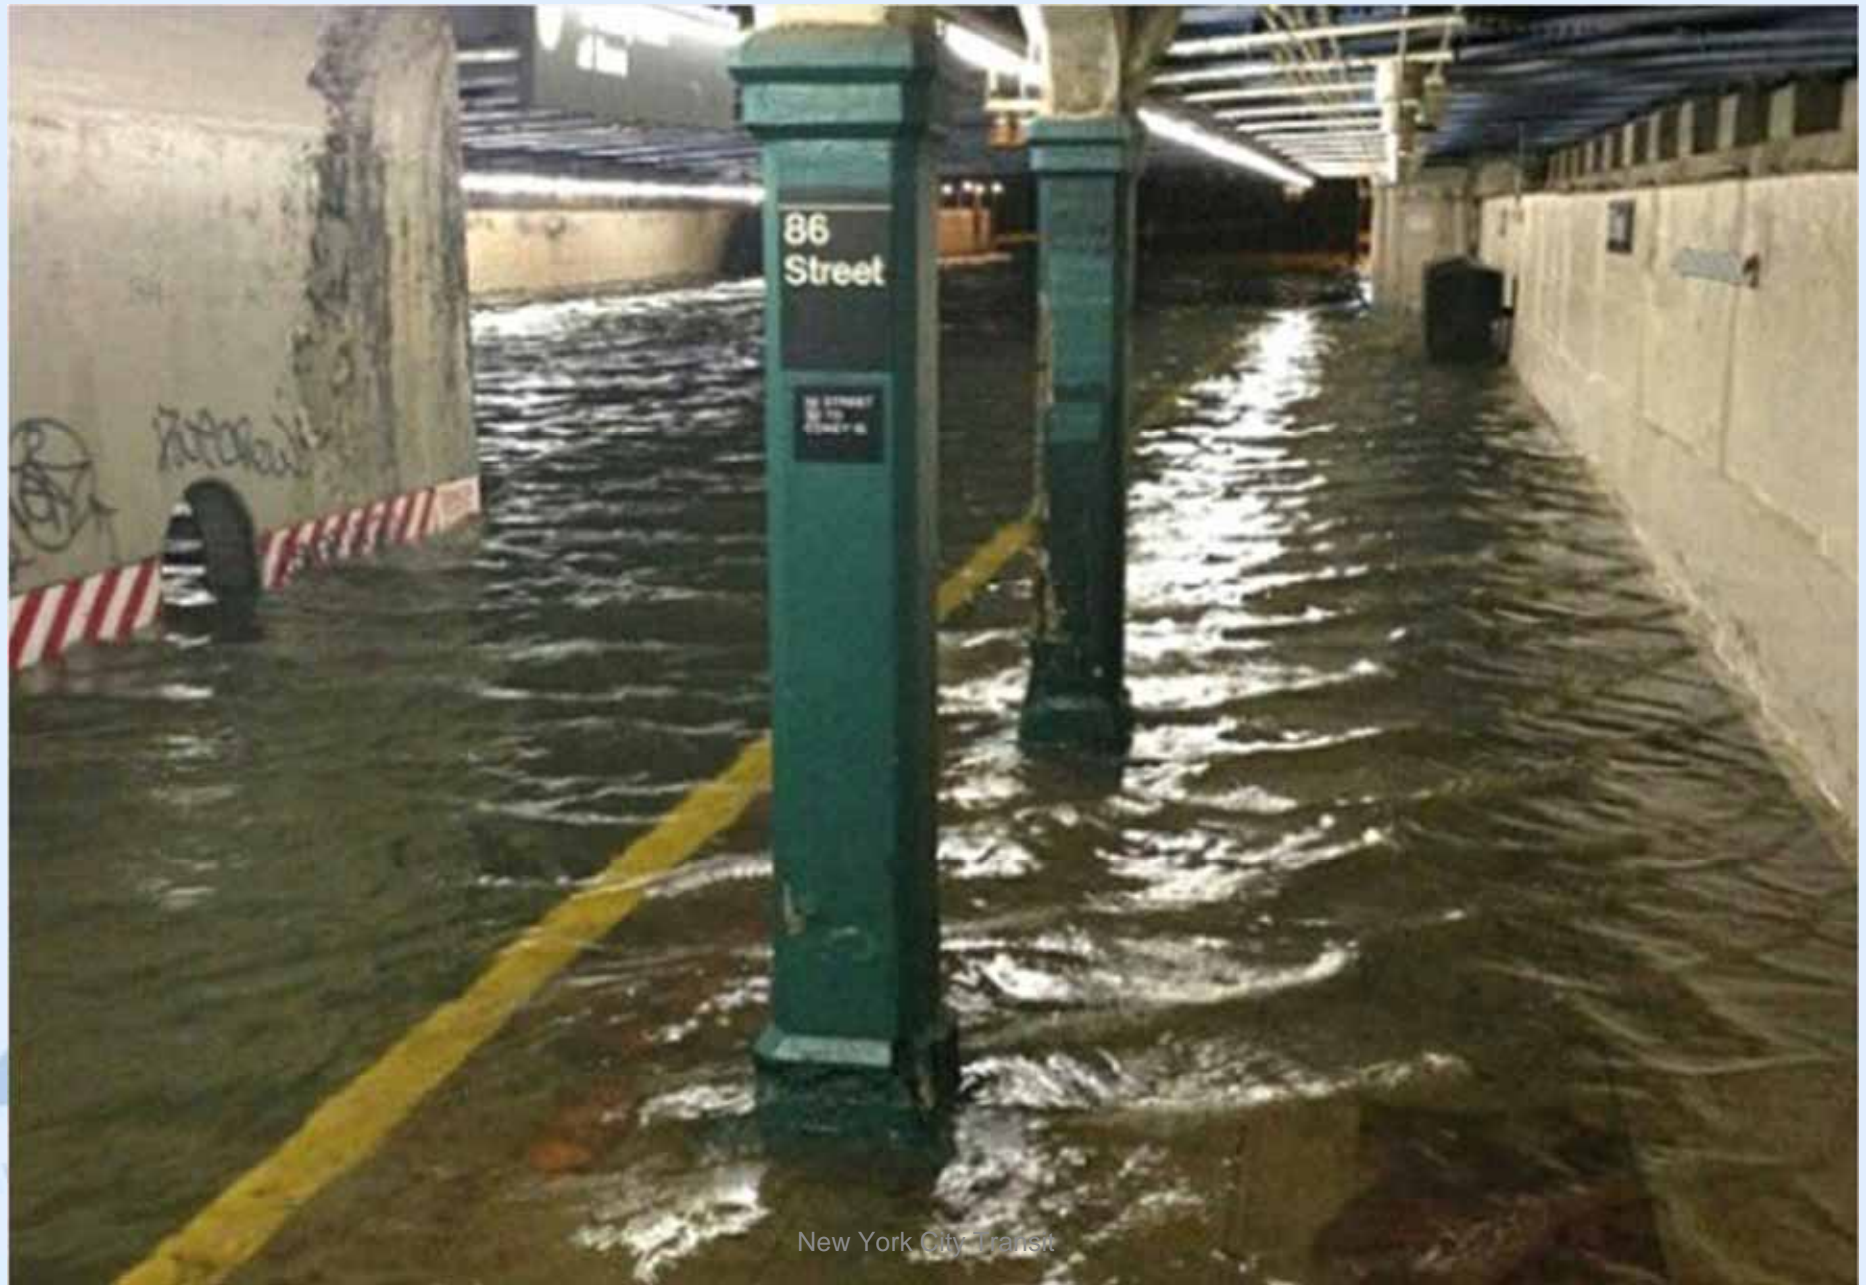
## Flooded stations – 86<sup>th</sup> St Sea Beach line

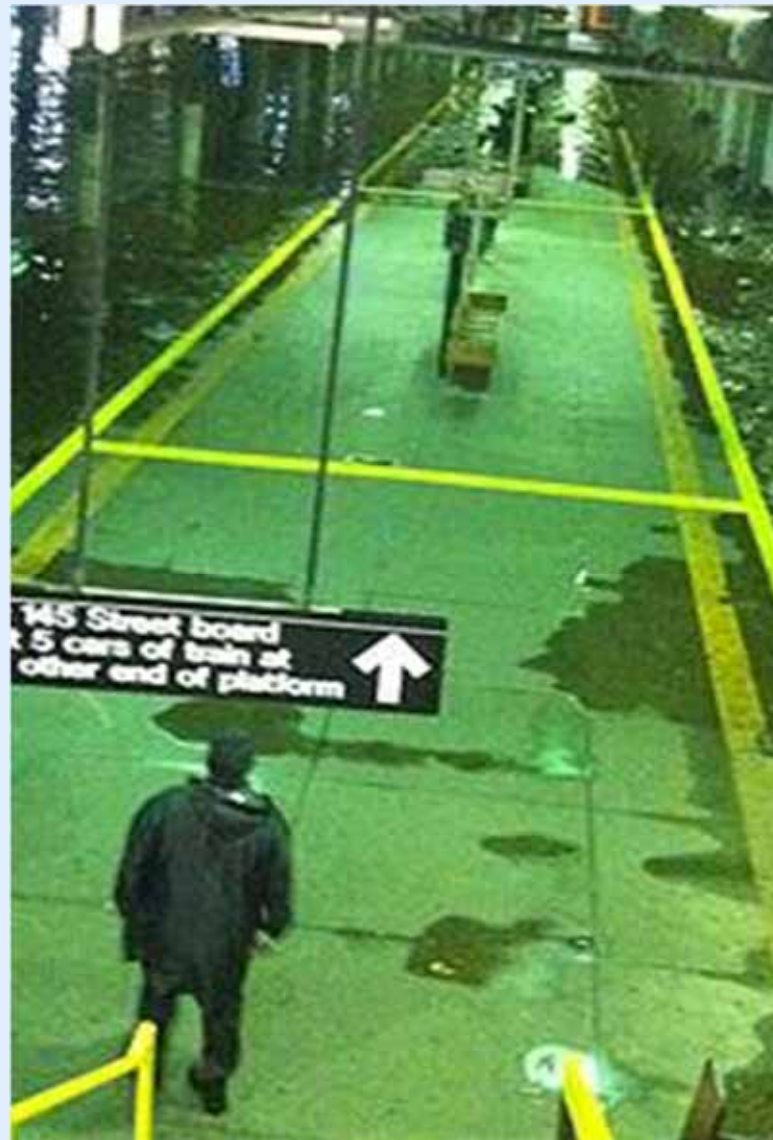
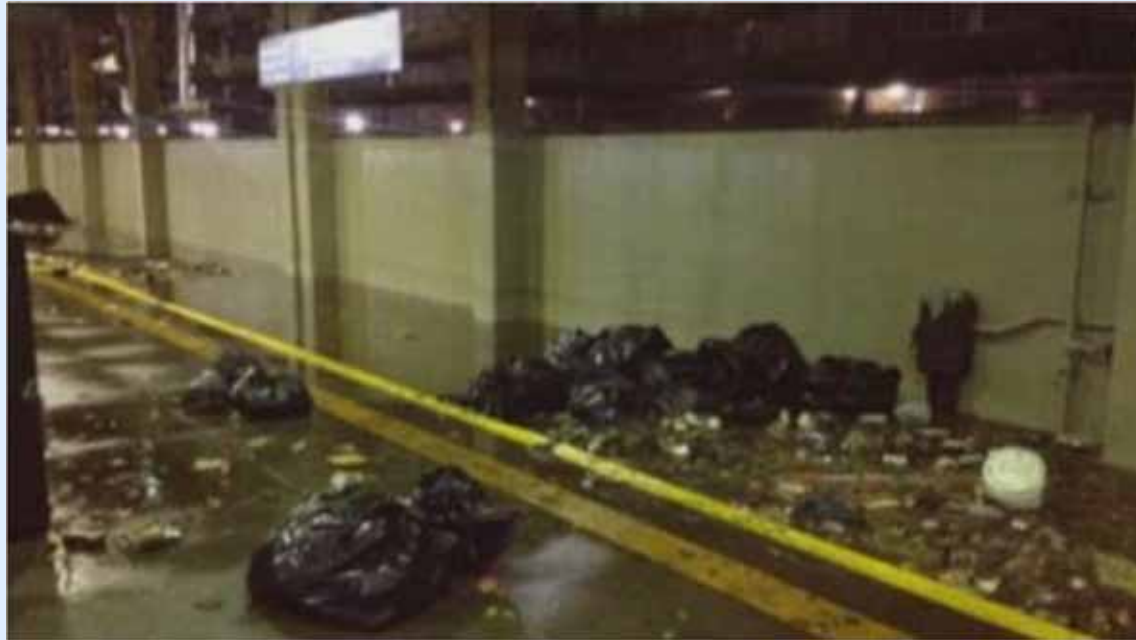
## Flooded stations – 148<sup>th</sup> St Harlem

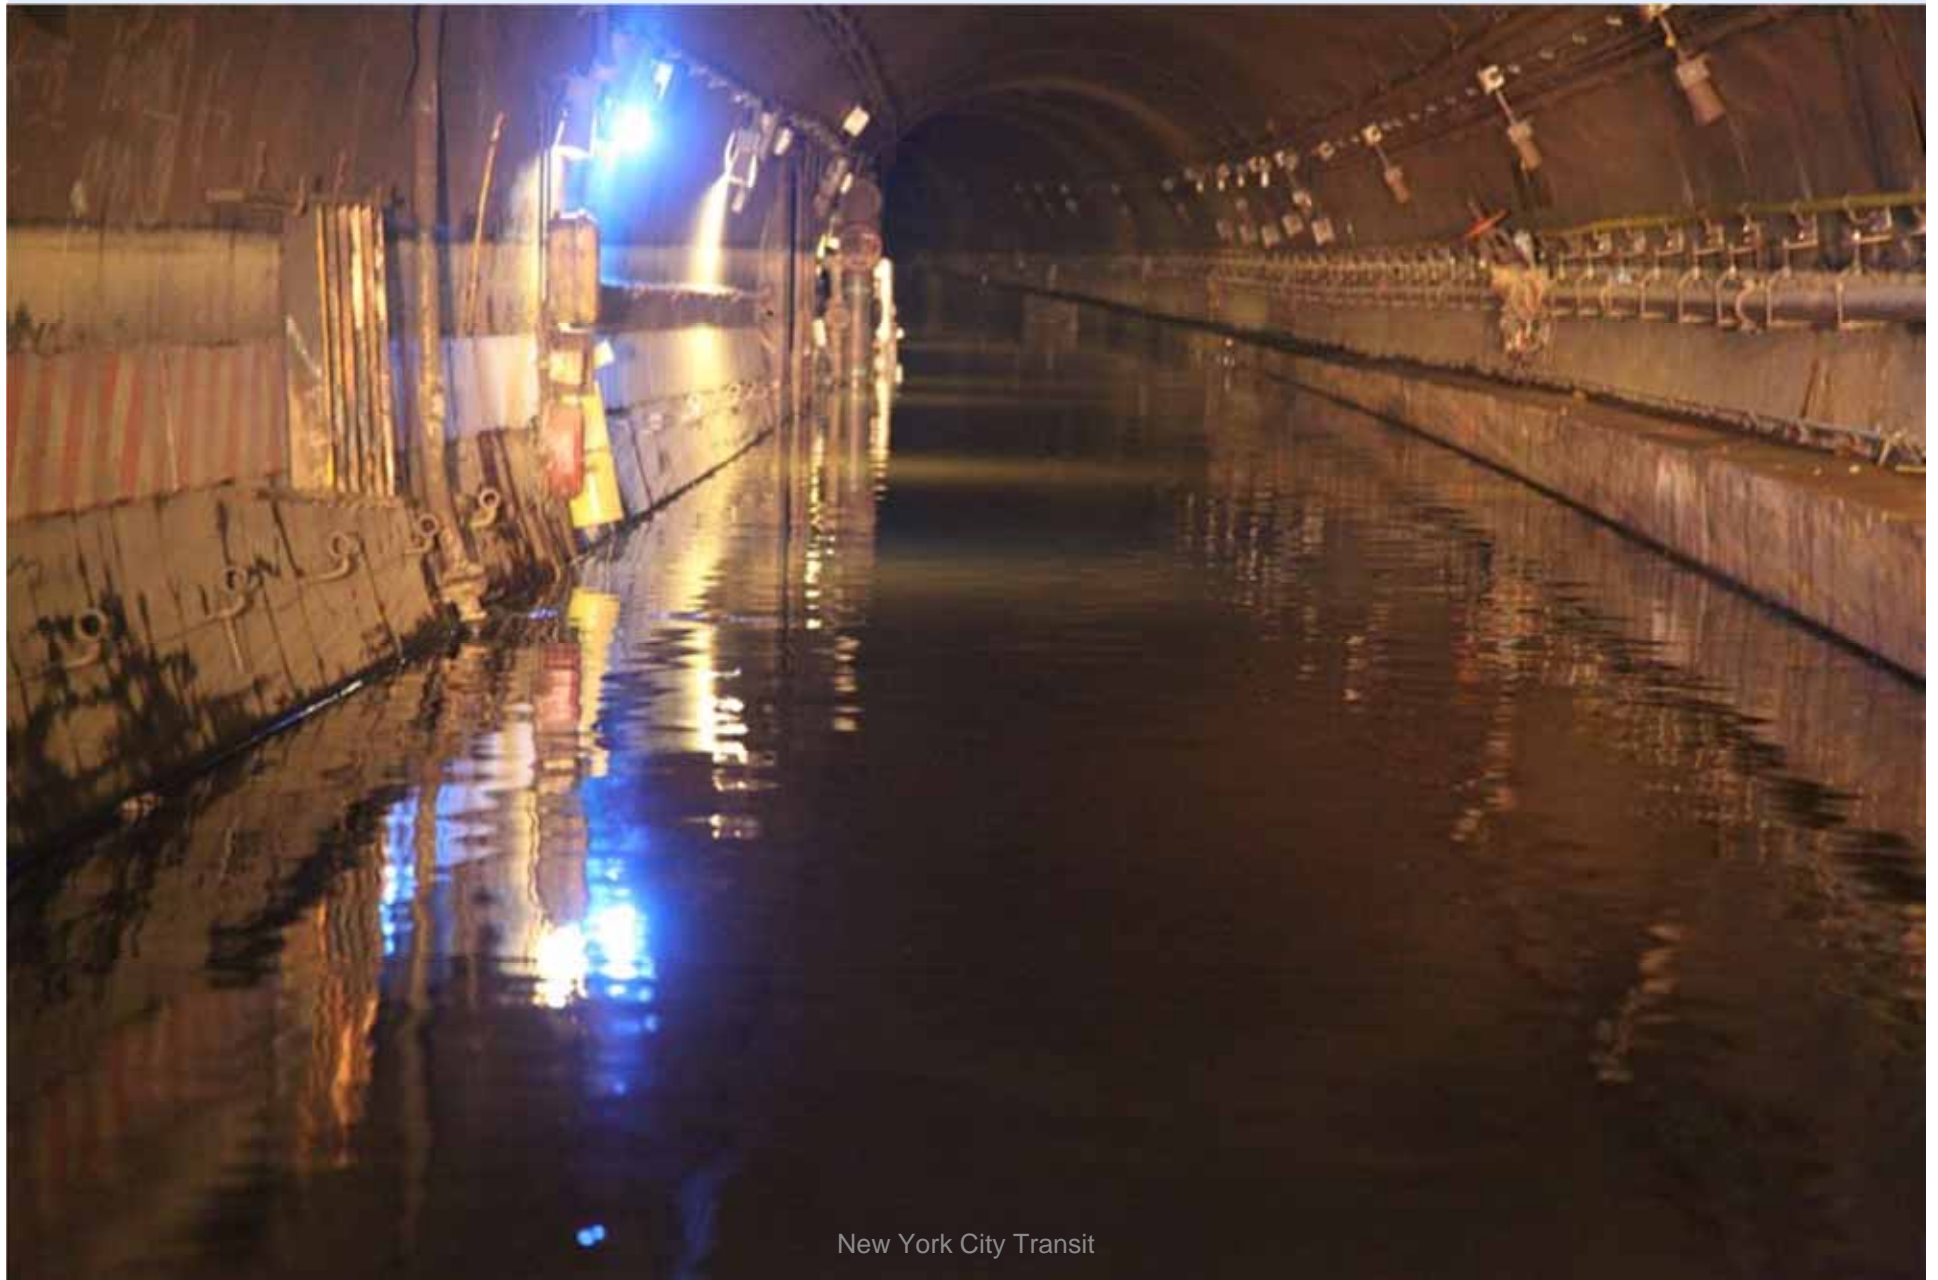
## Flooded under-river tubes - Cranberry

- Operating in 2 sections – no service between 34 St – Herald Sq and Jay St Metrotech
- Significant damage to electrical systems in Montague tube – restoration work underway
- Flood damage to Whitehall Station
- Expect to extend service from 34<sup>th</sup> St to Whitehall St as next step in restoration

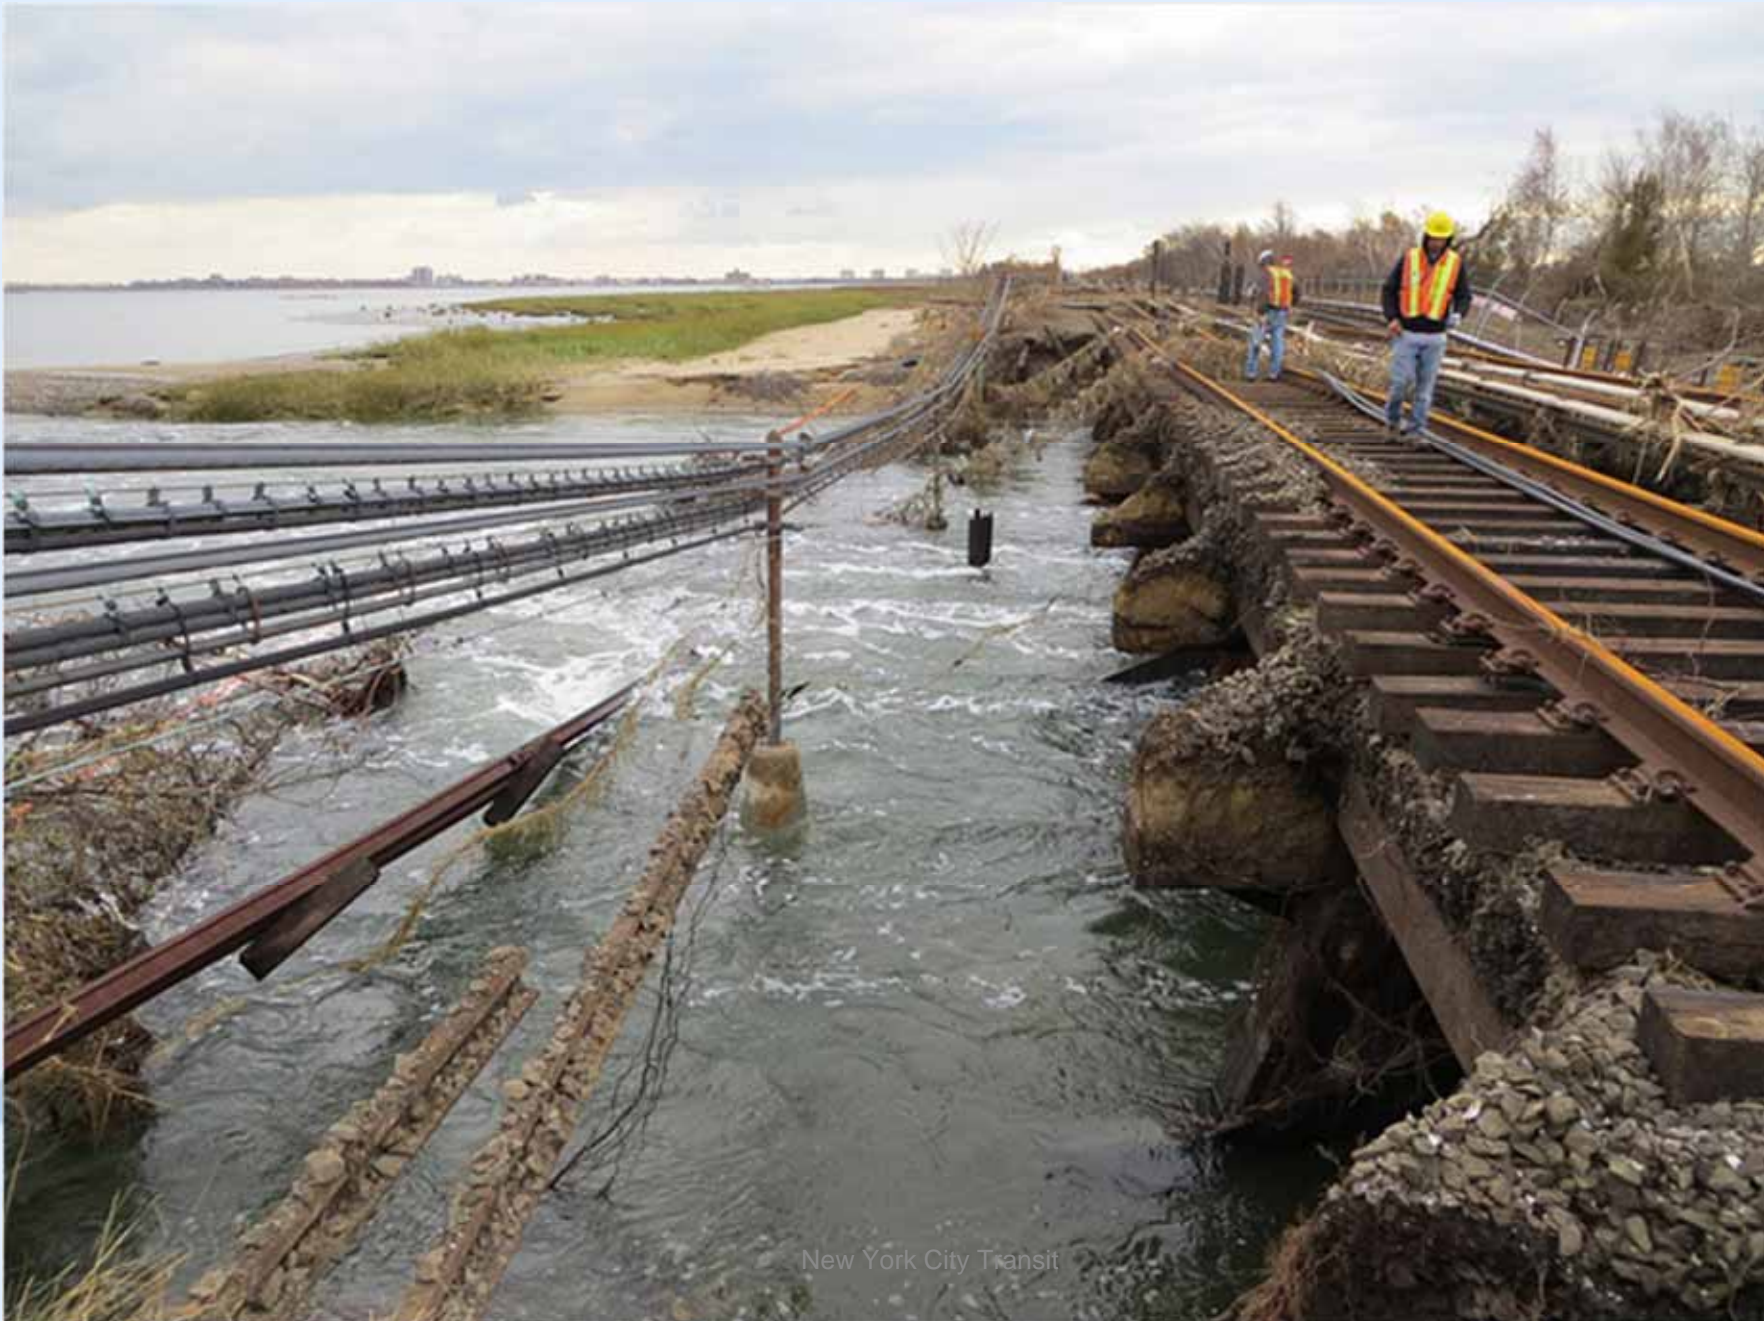
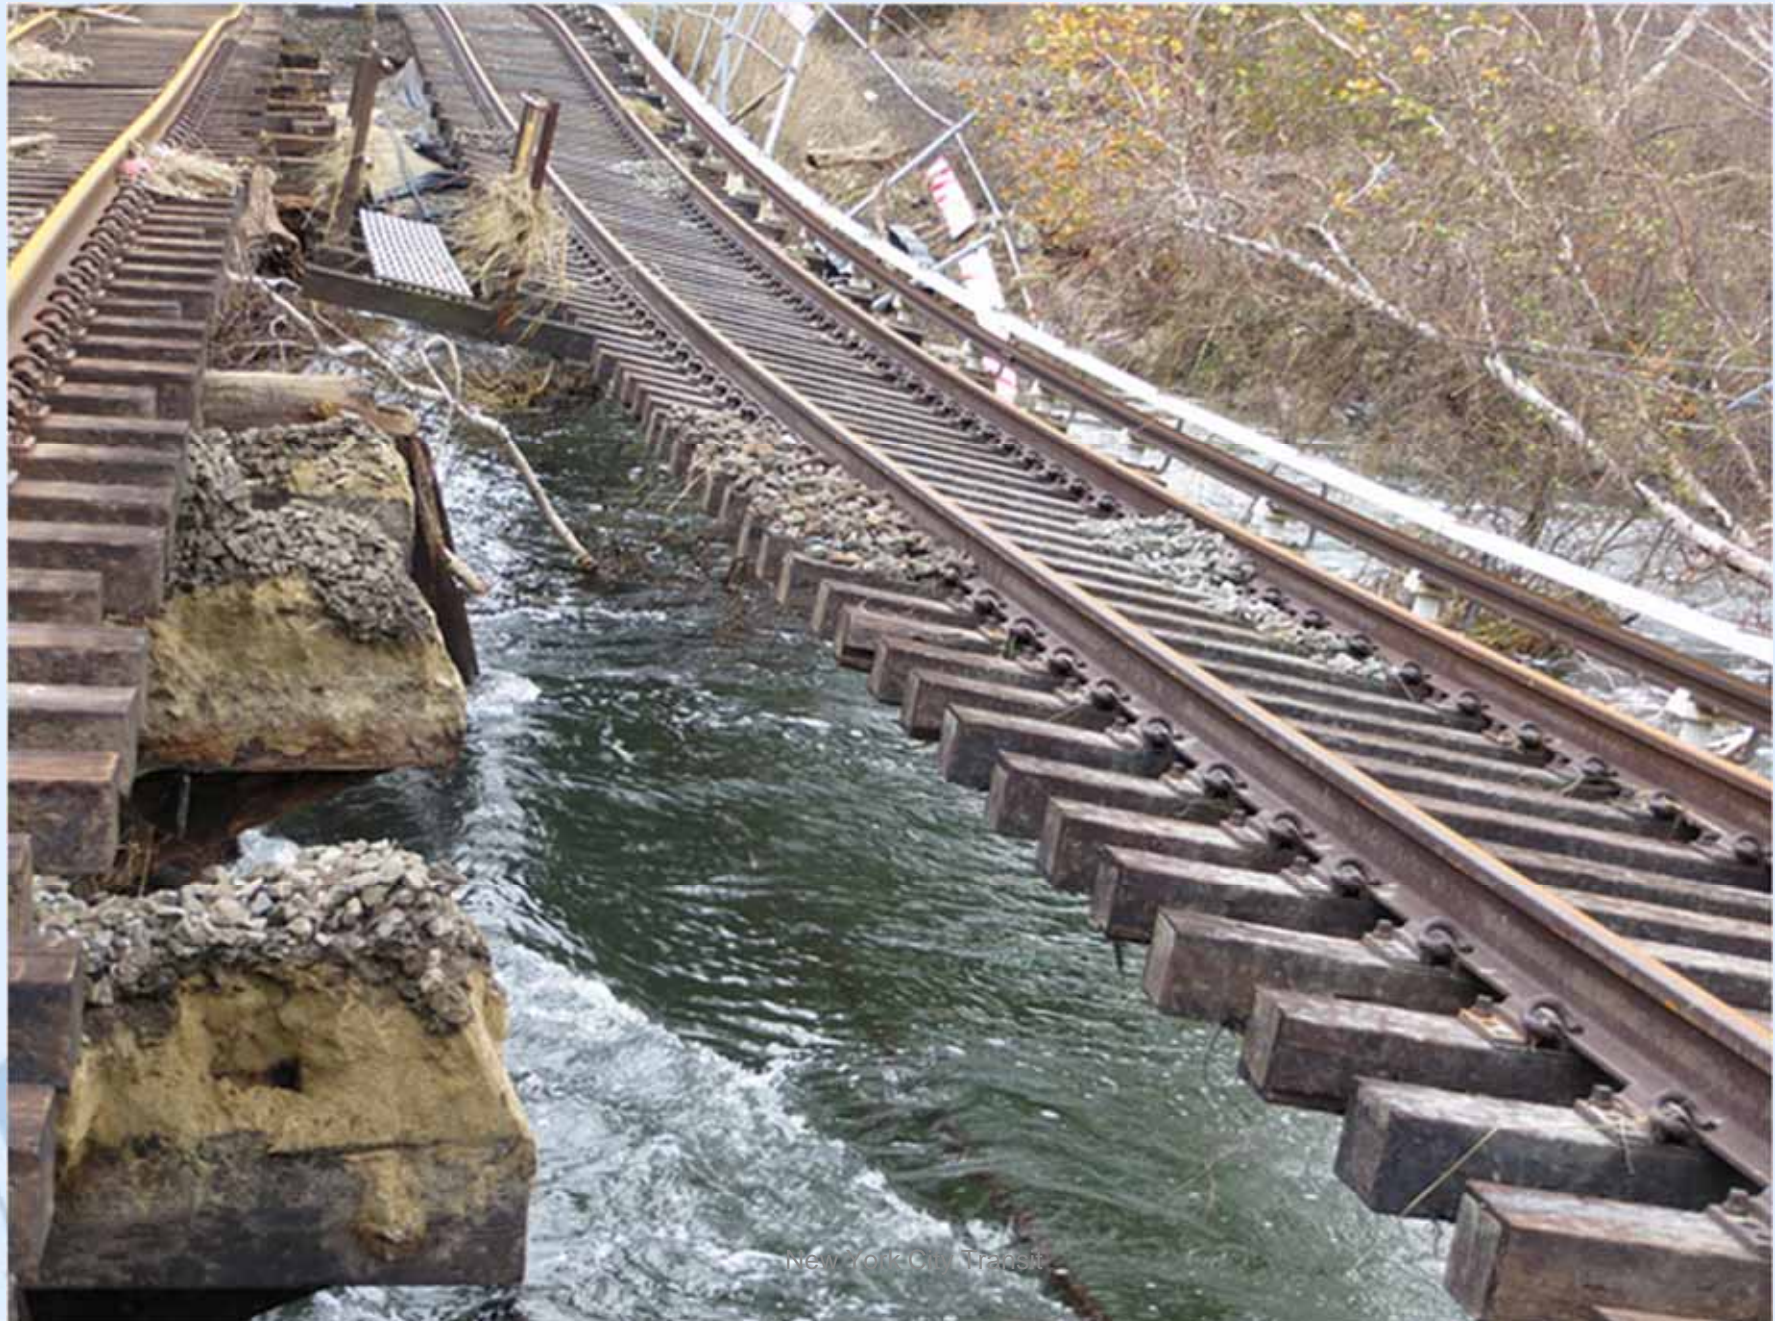
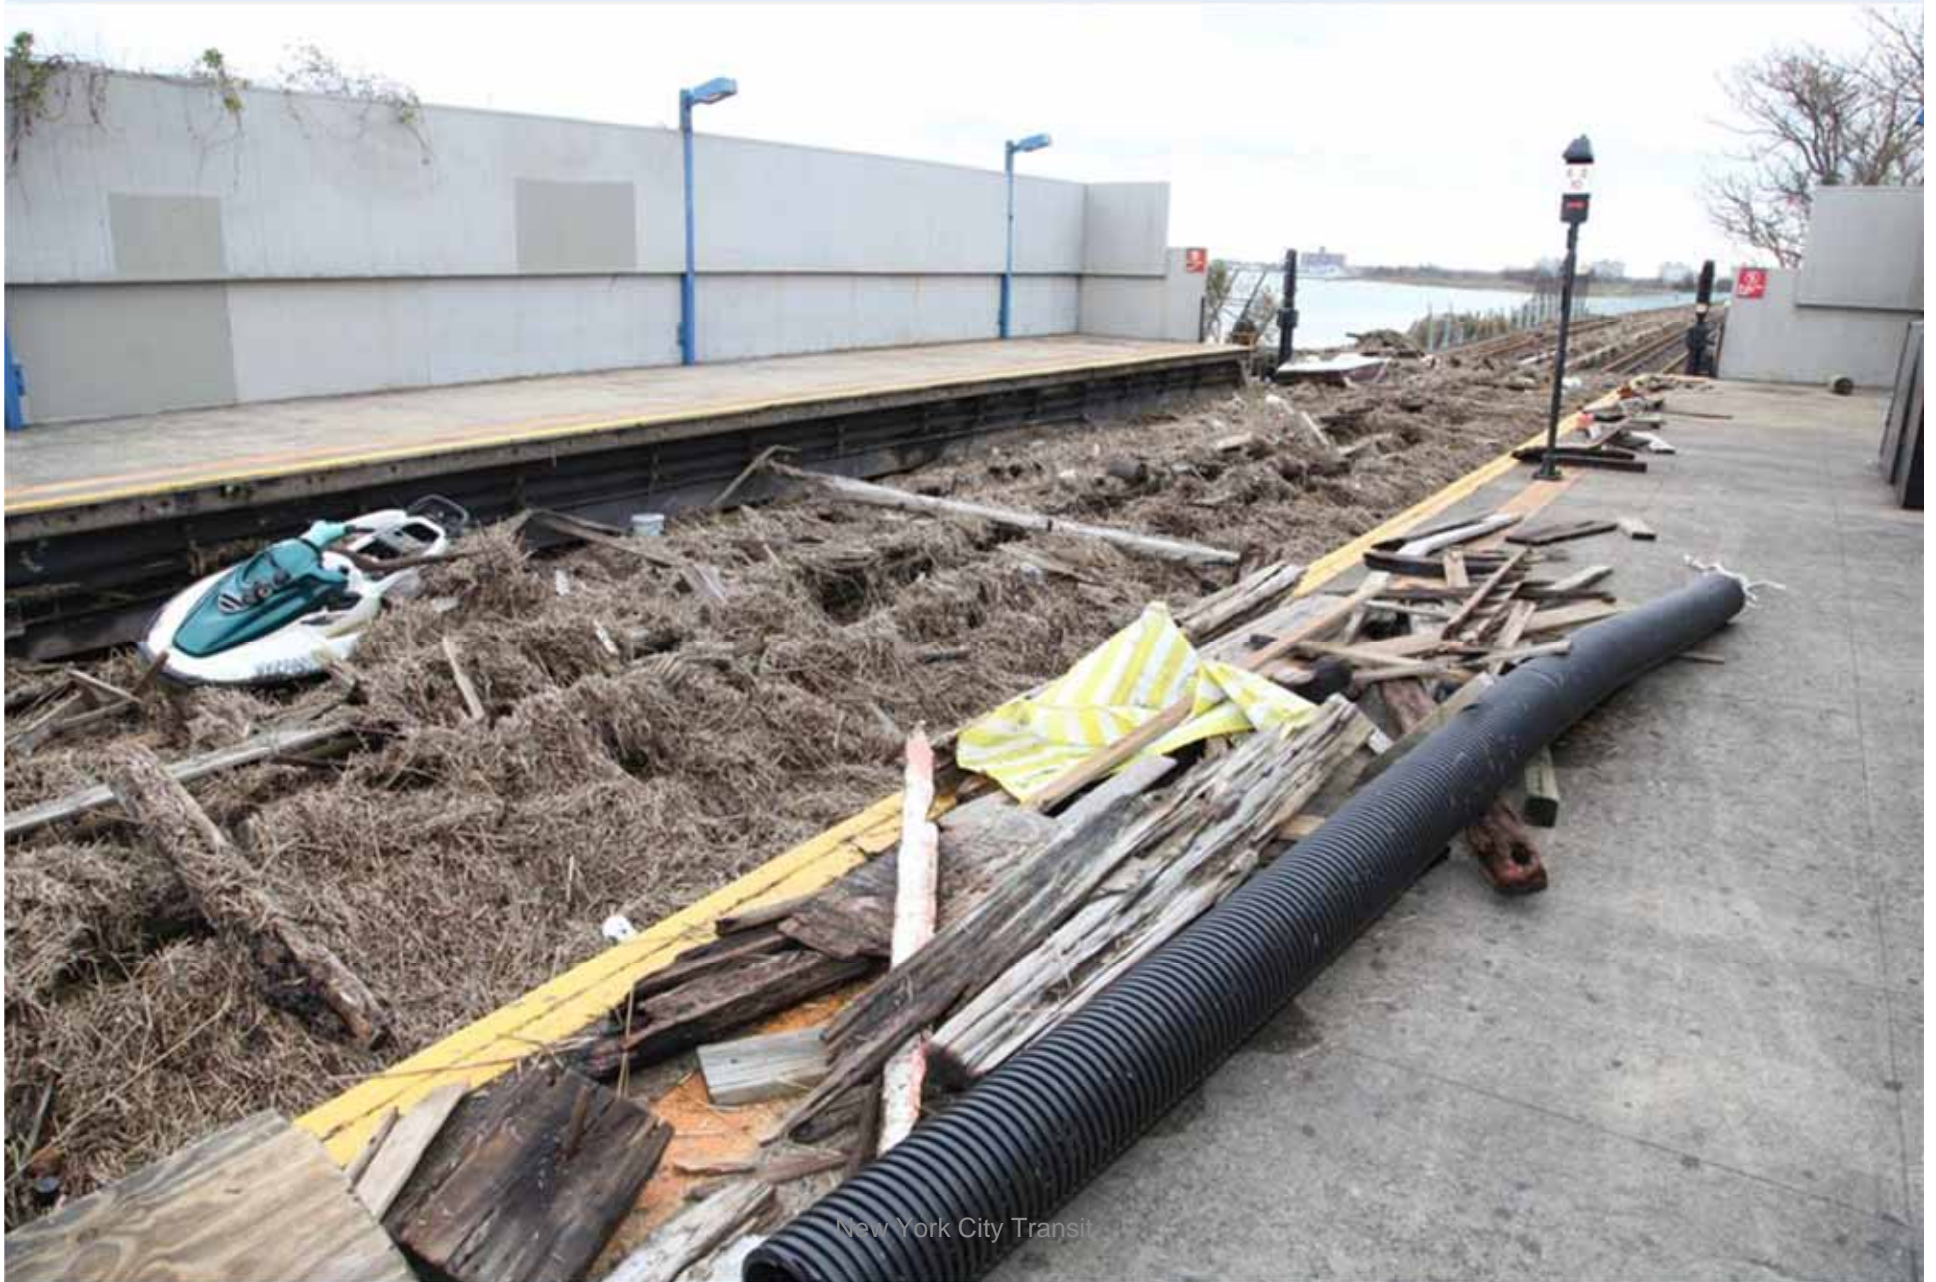
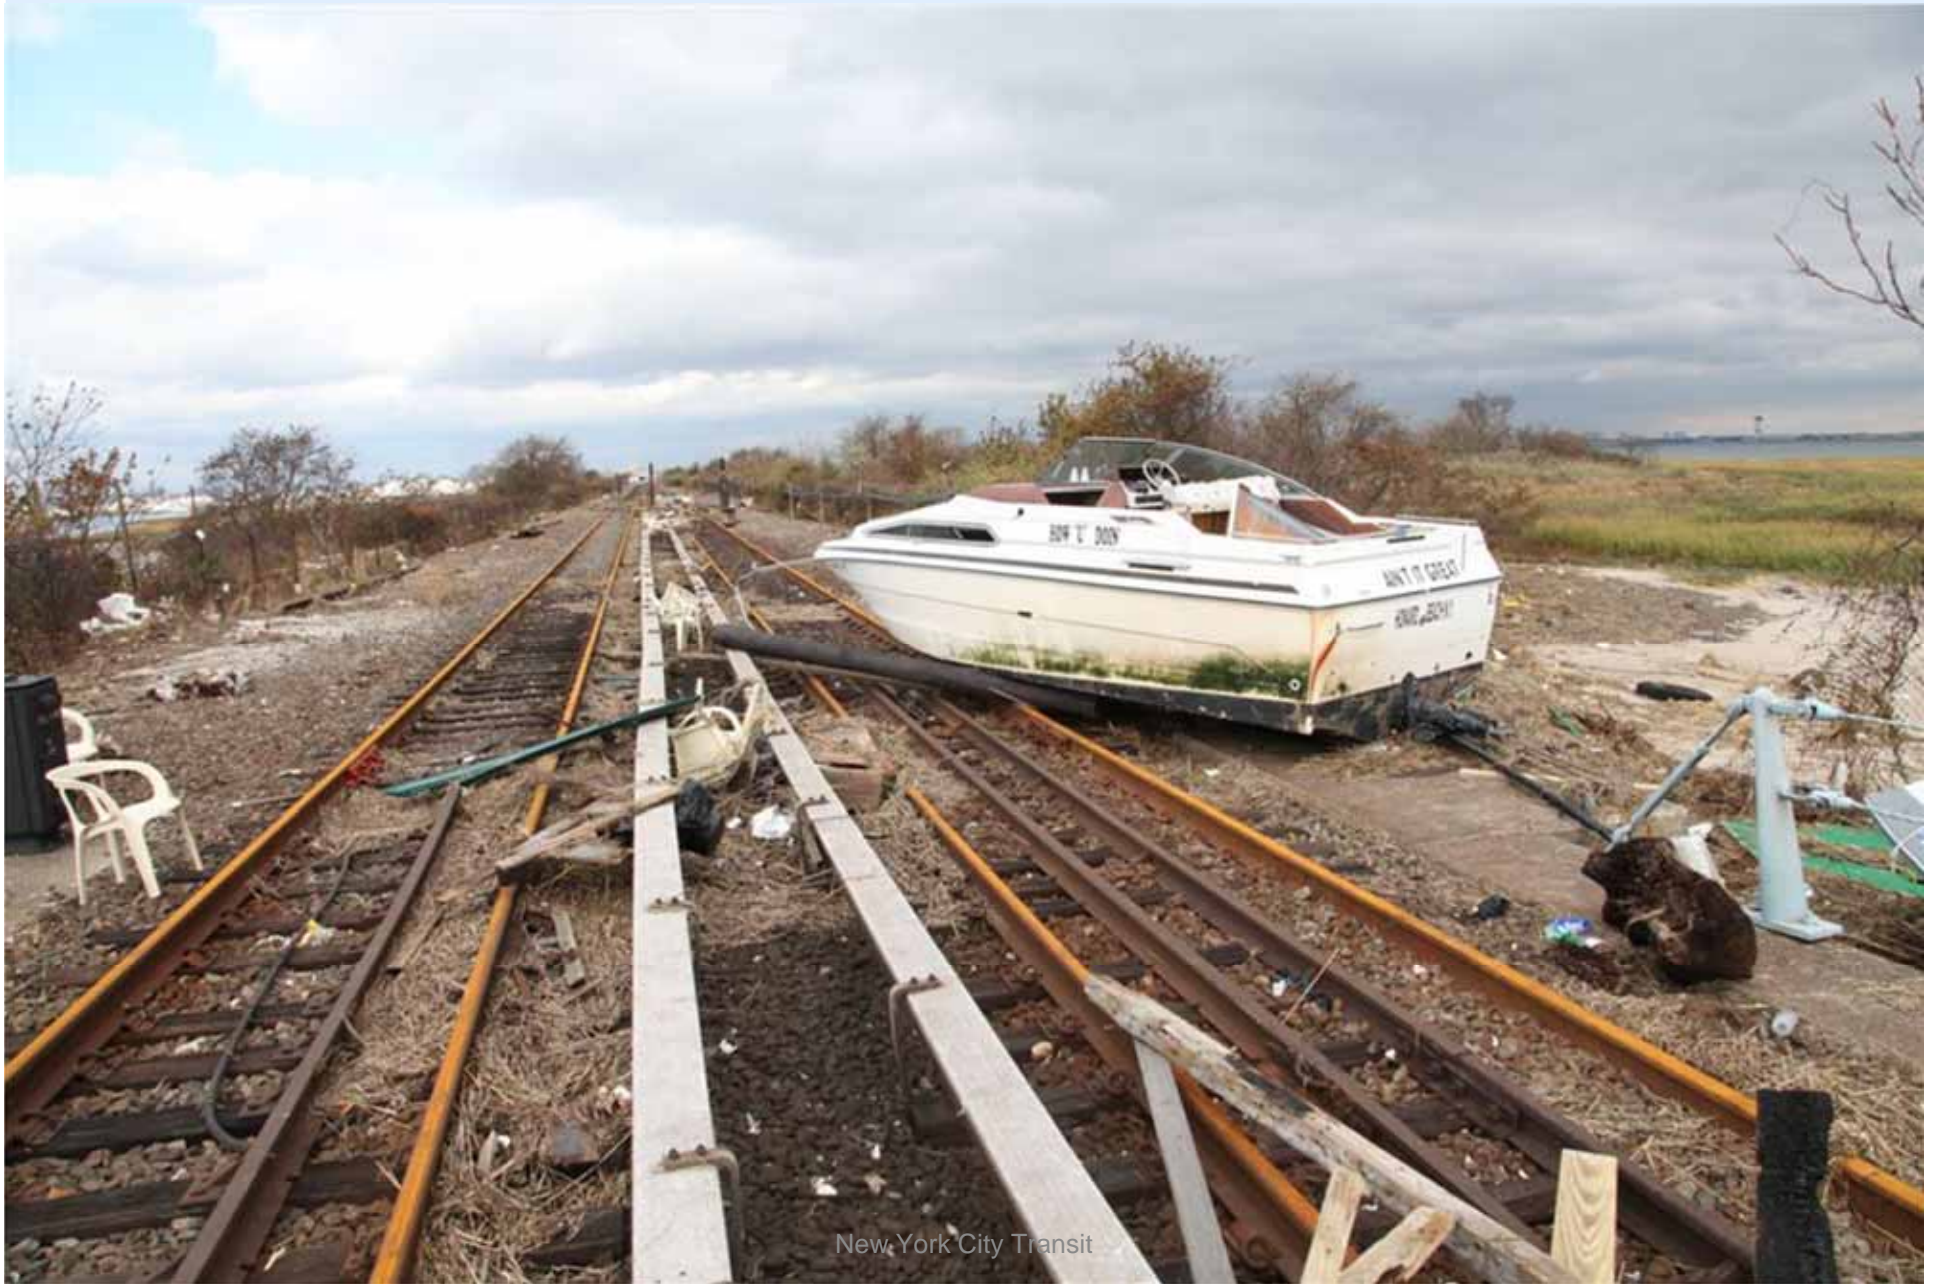
## Rockaways track washout

- Work underway to restore washed out track sections over Jamaica Bay
- Work underway to assess and repair signal system at Rockaway Park
- **H** shuttle operating on peninsula with bus shuttle connection to Howard Beach

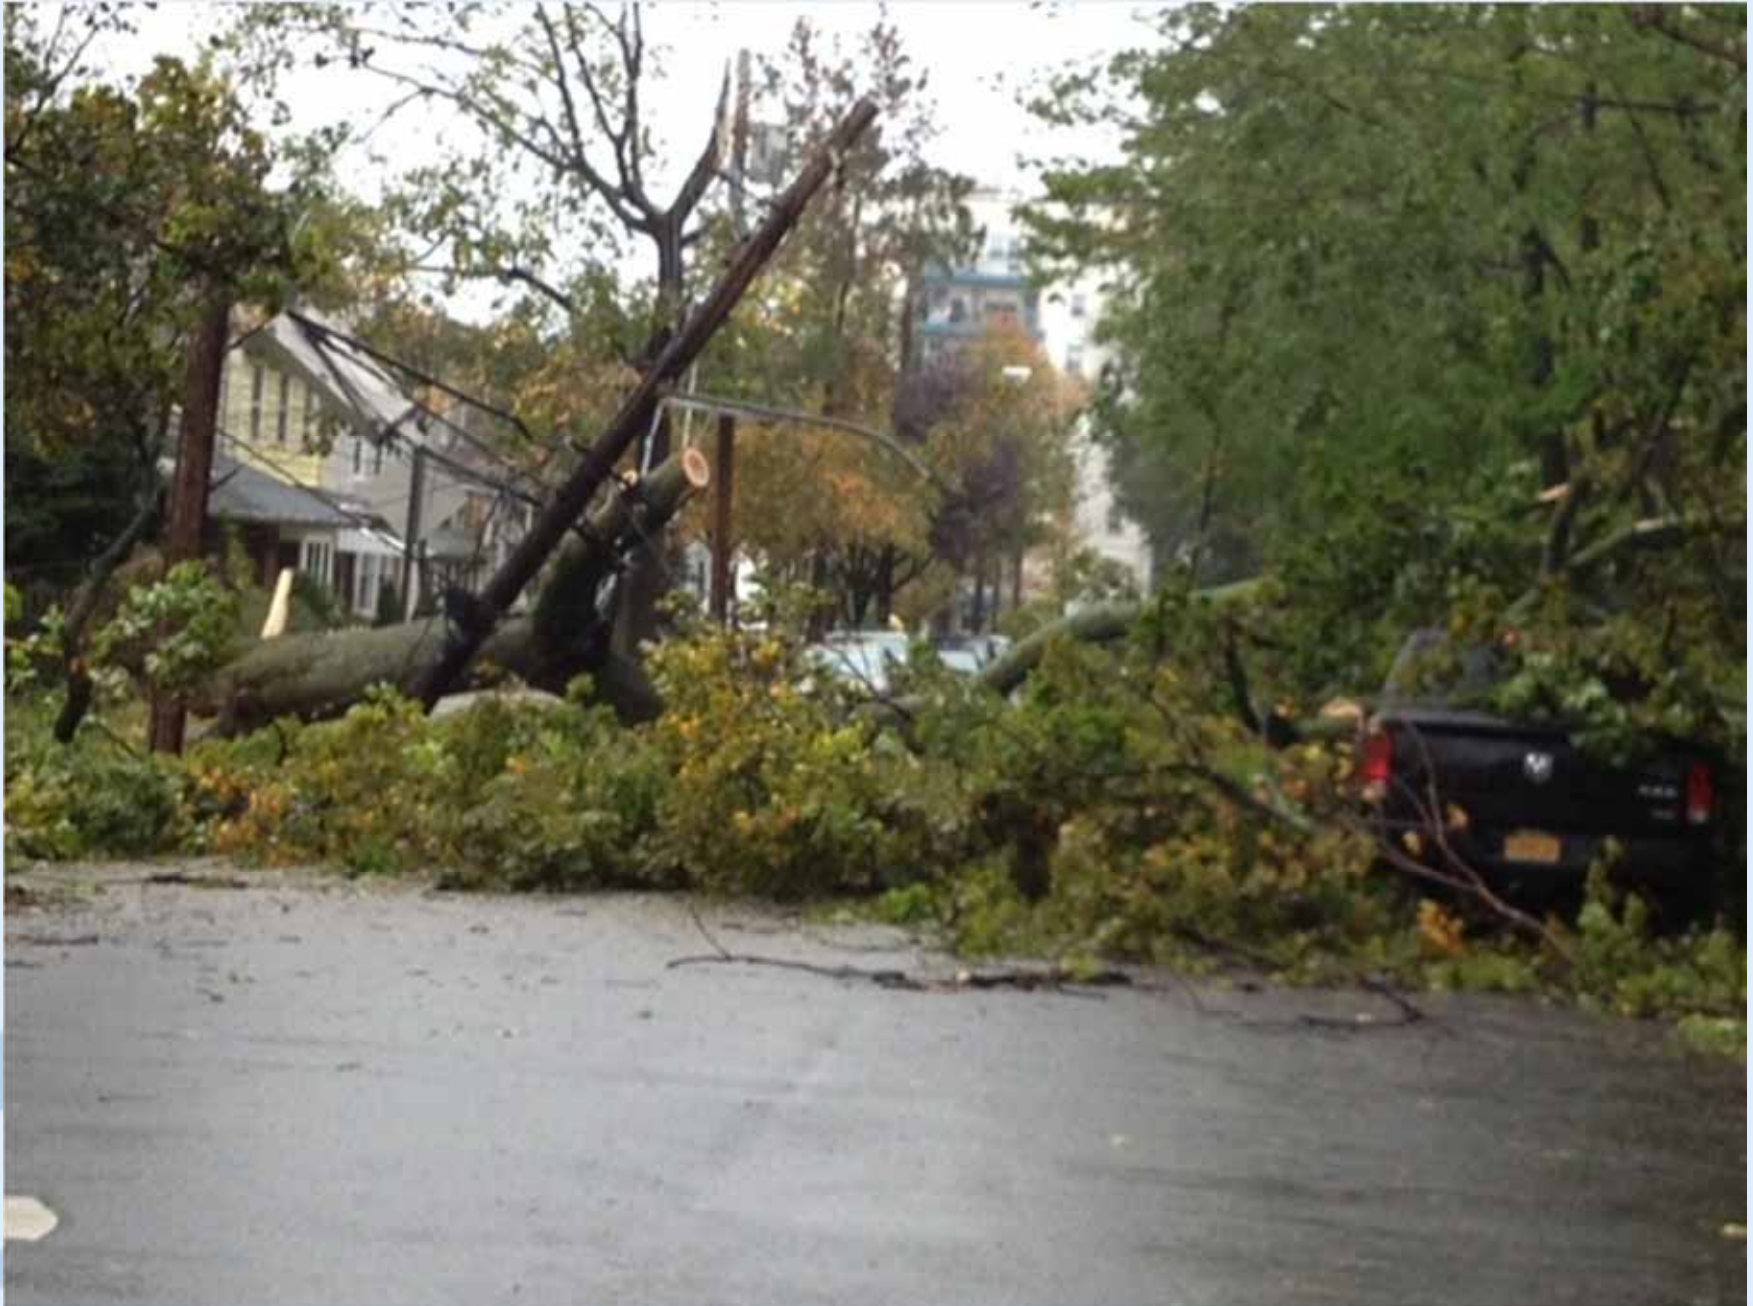
## Bus routes impassable

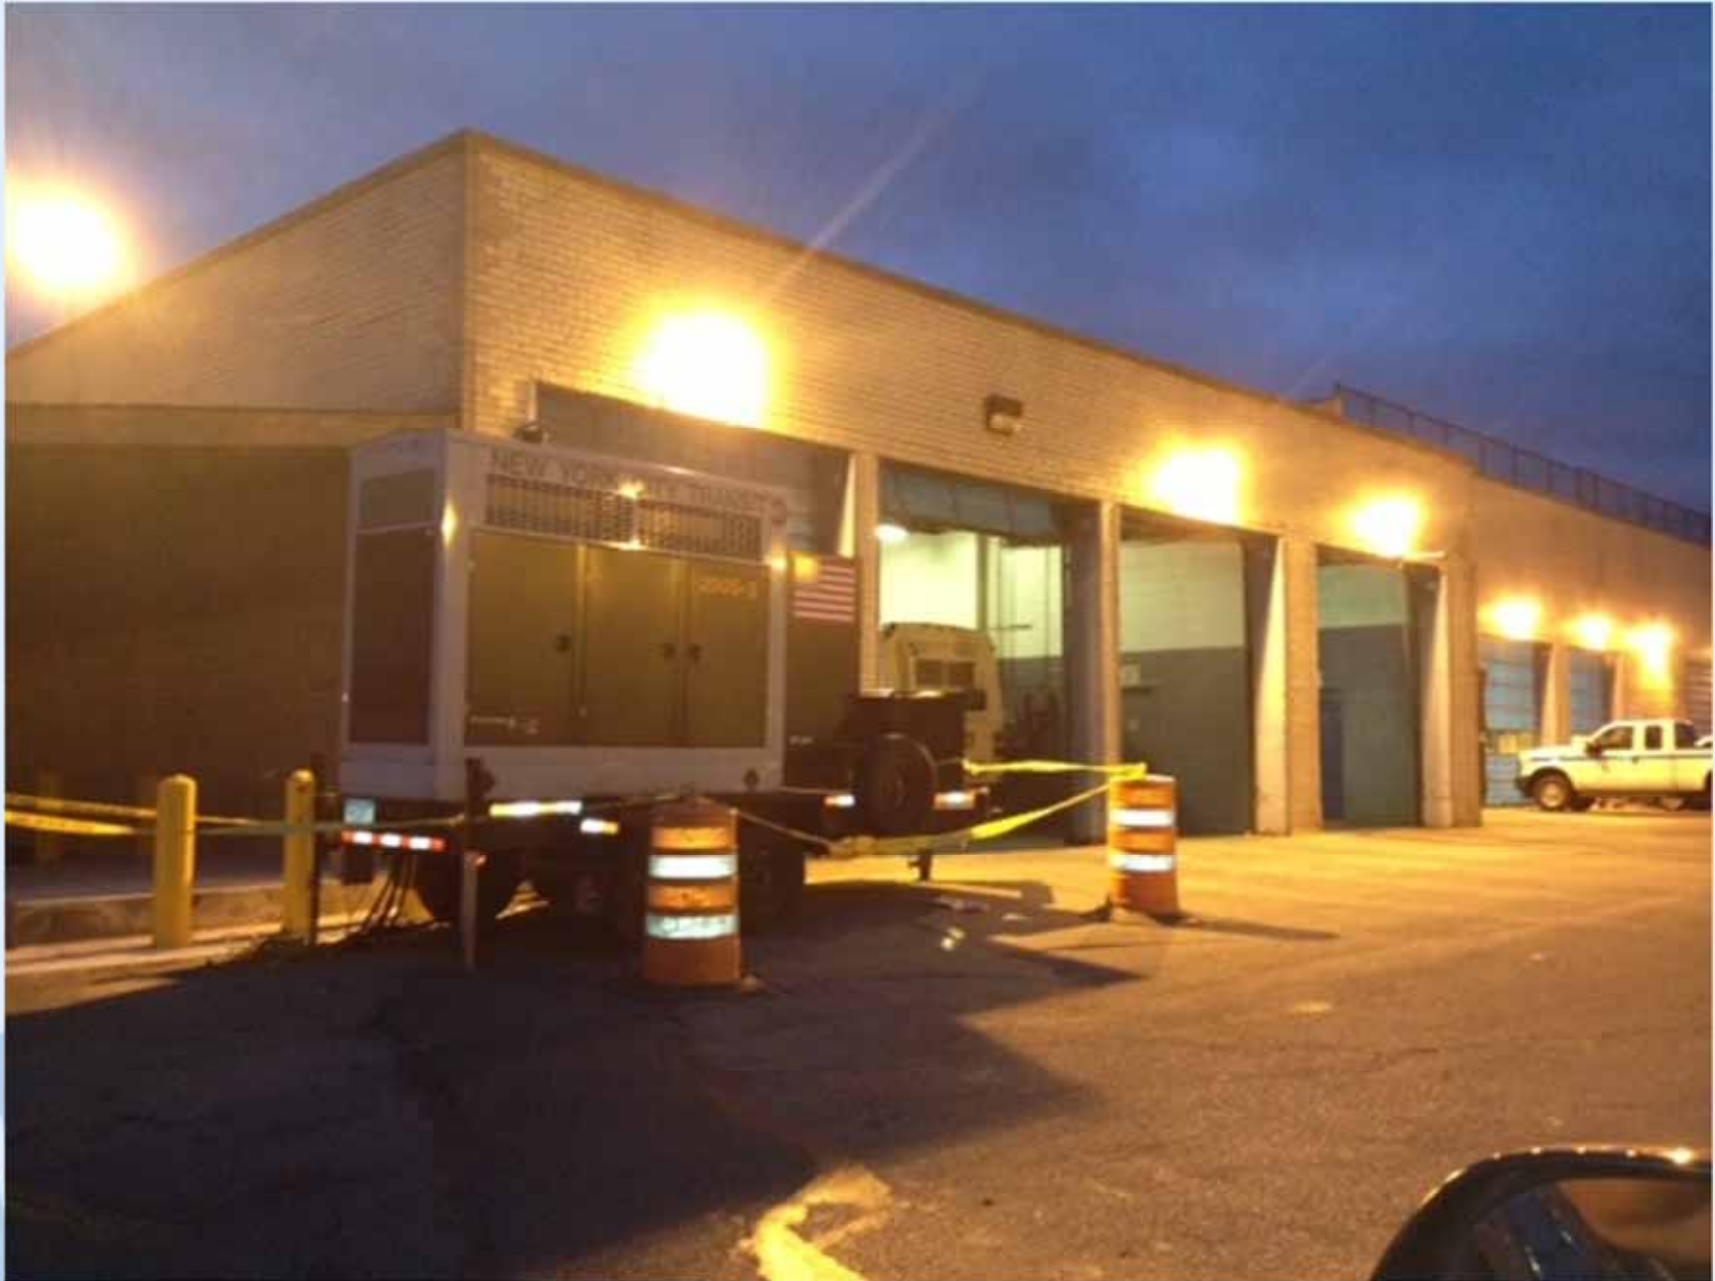
## Facilities operated on local generator power

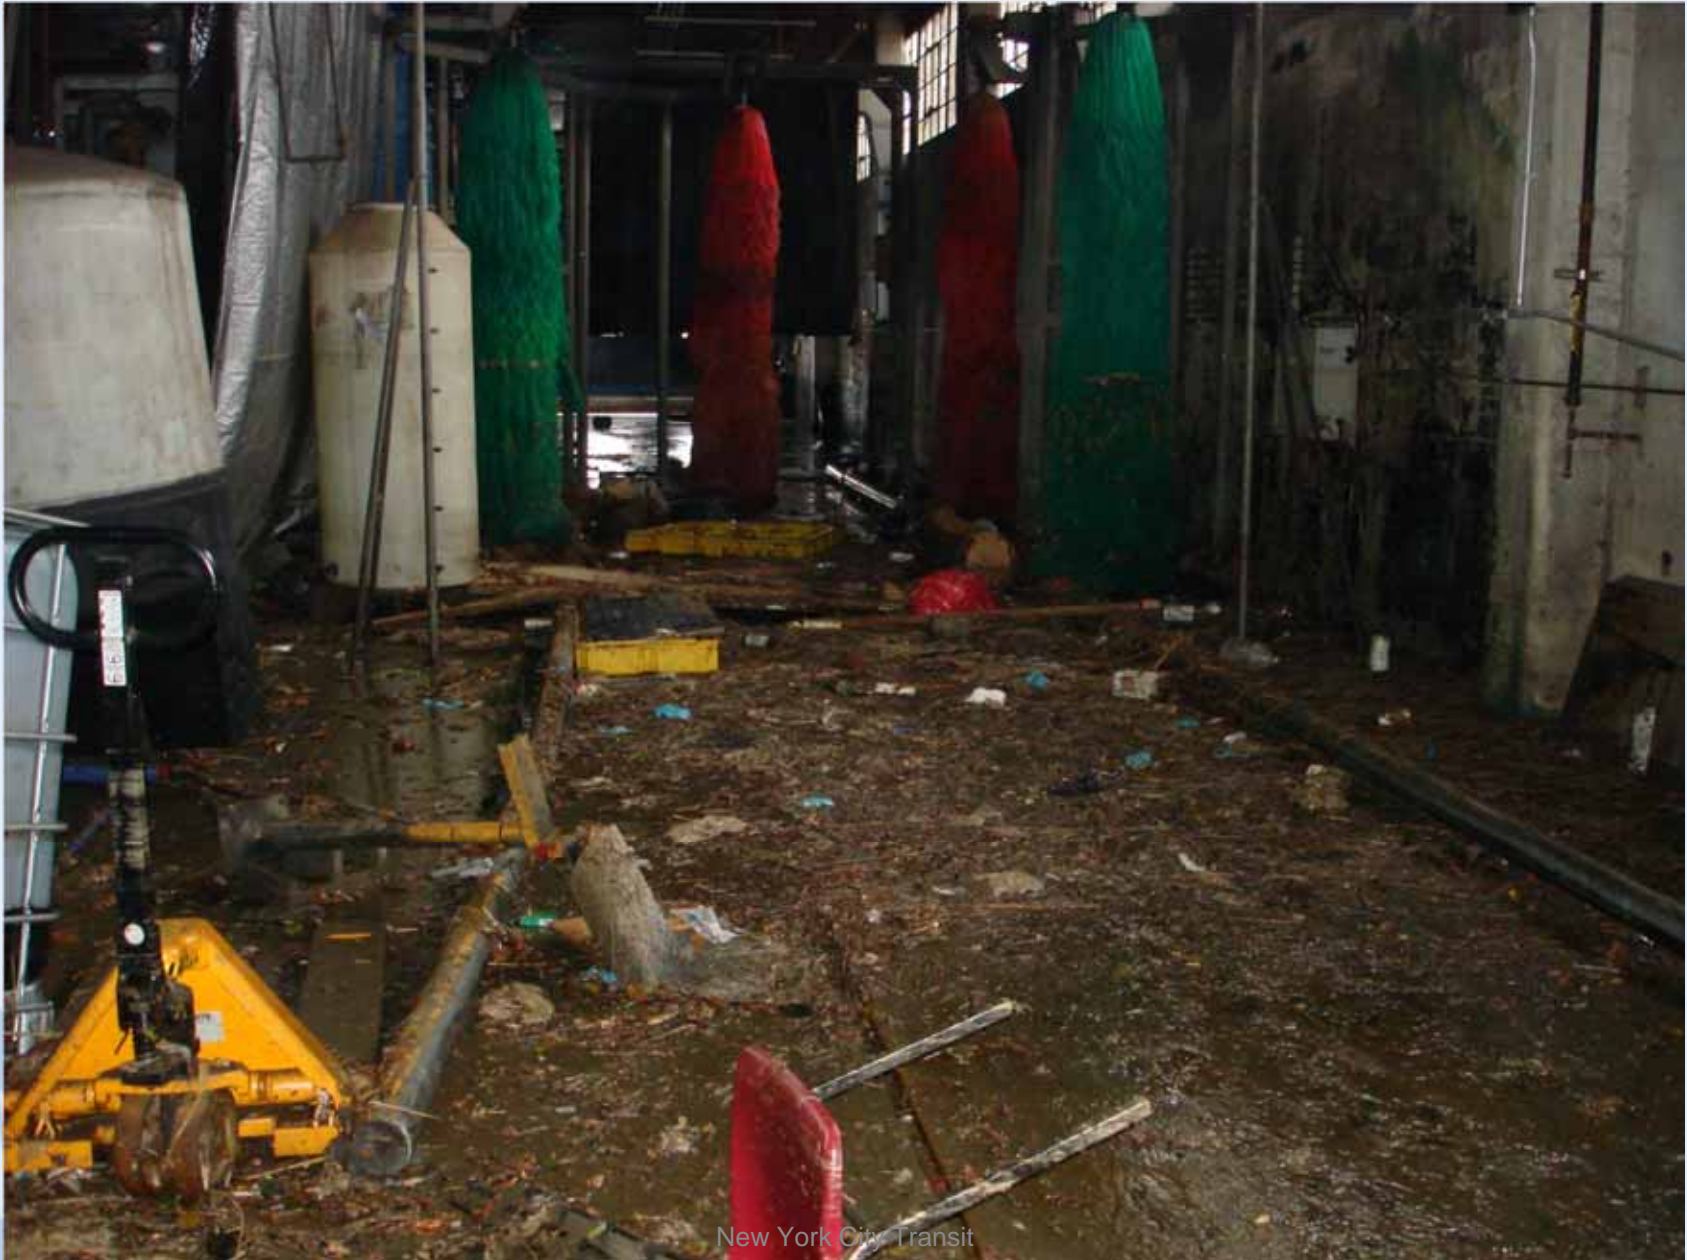
## Bus depot flooding – Far Rockaway

- Evaluation and assessment of plans for Far Rockaway Depot
- Buses being run out of JFK depot
