# Hurricane Sandy

Overview of Subway and Bus preparations,  
impact and recovery  
NYCT Committee Meeting  
November 26, 2012

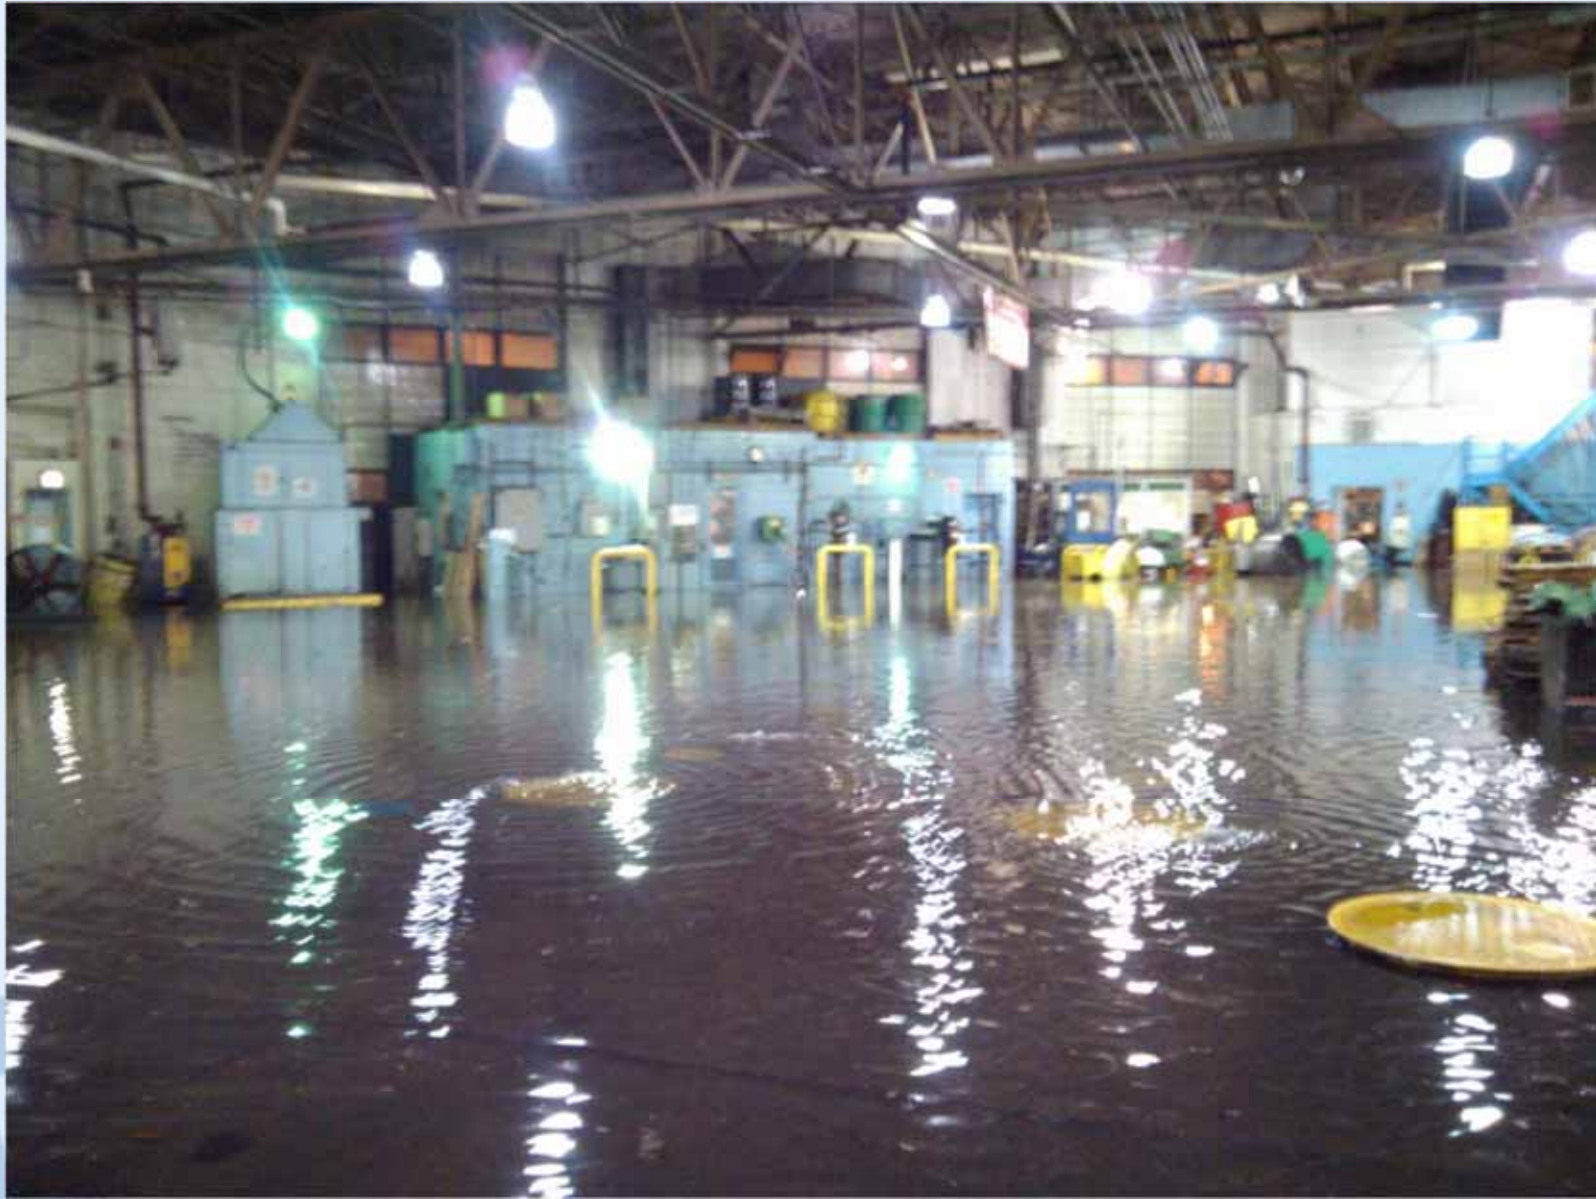
## Bus depot flooding – 126<sup>th</sup> St

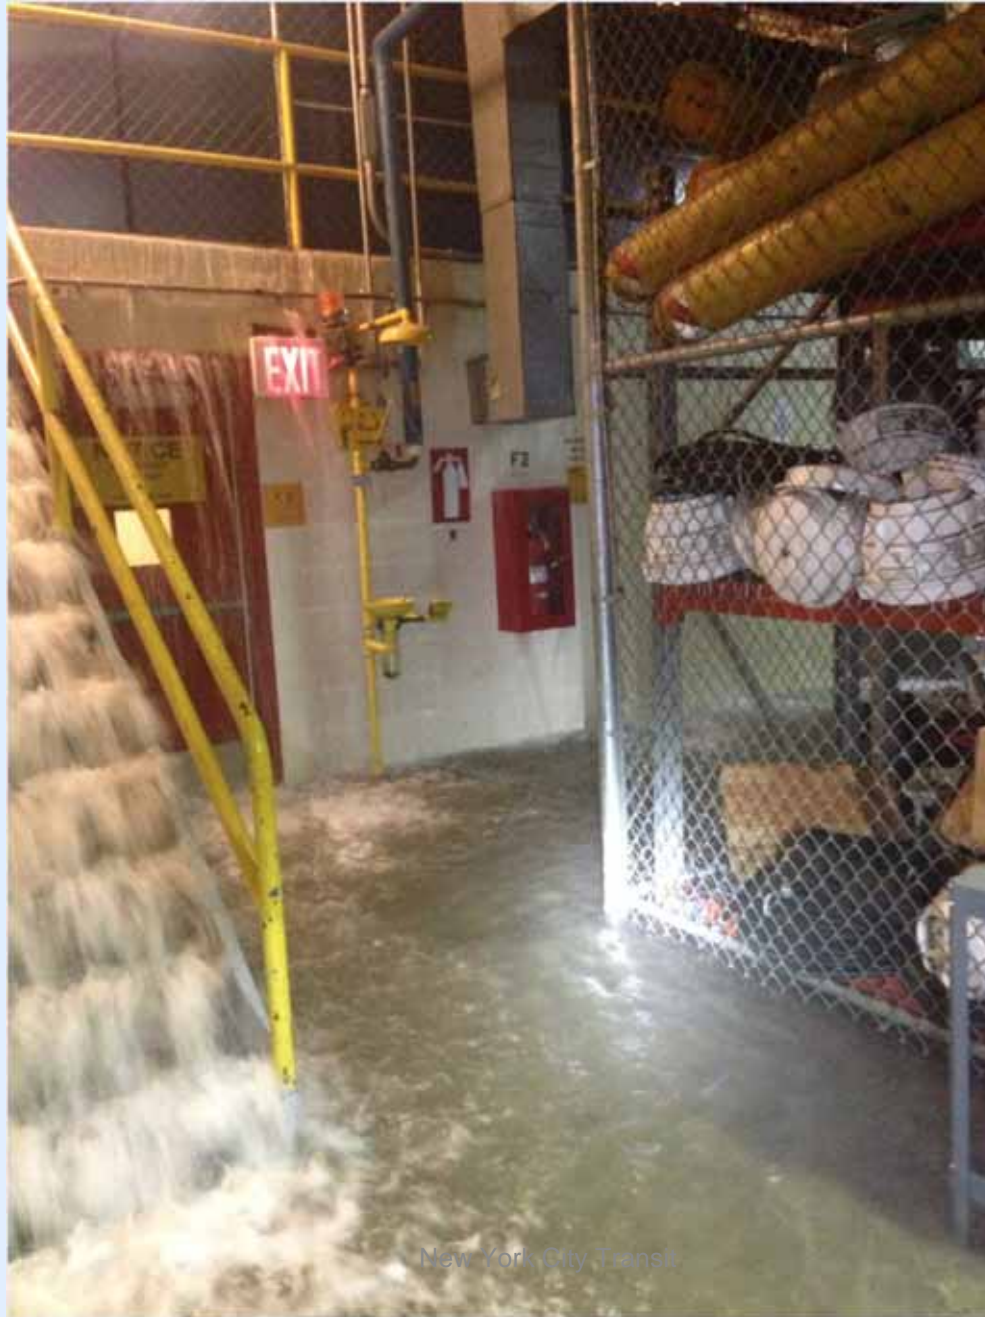
## Bus depot flooding – Quill

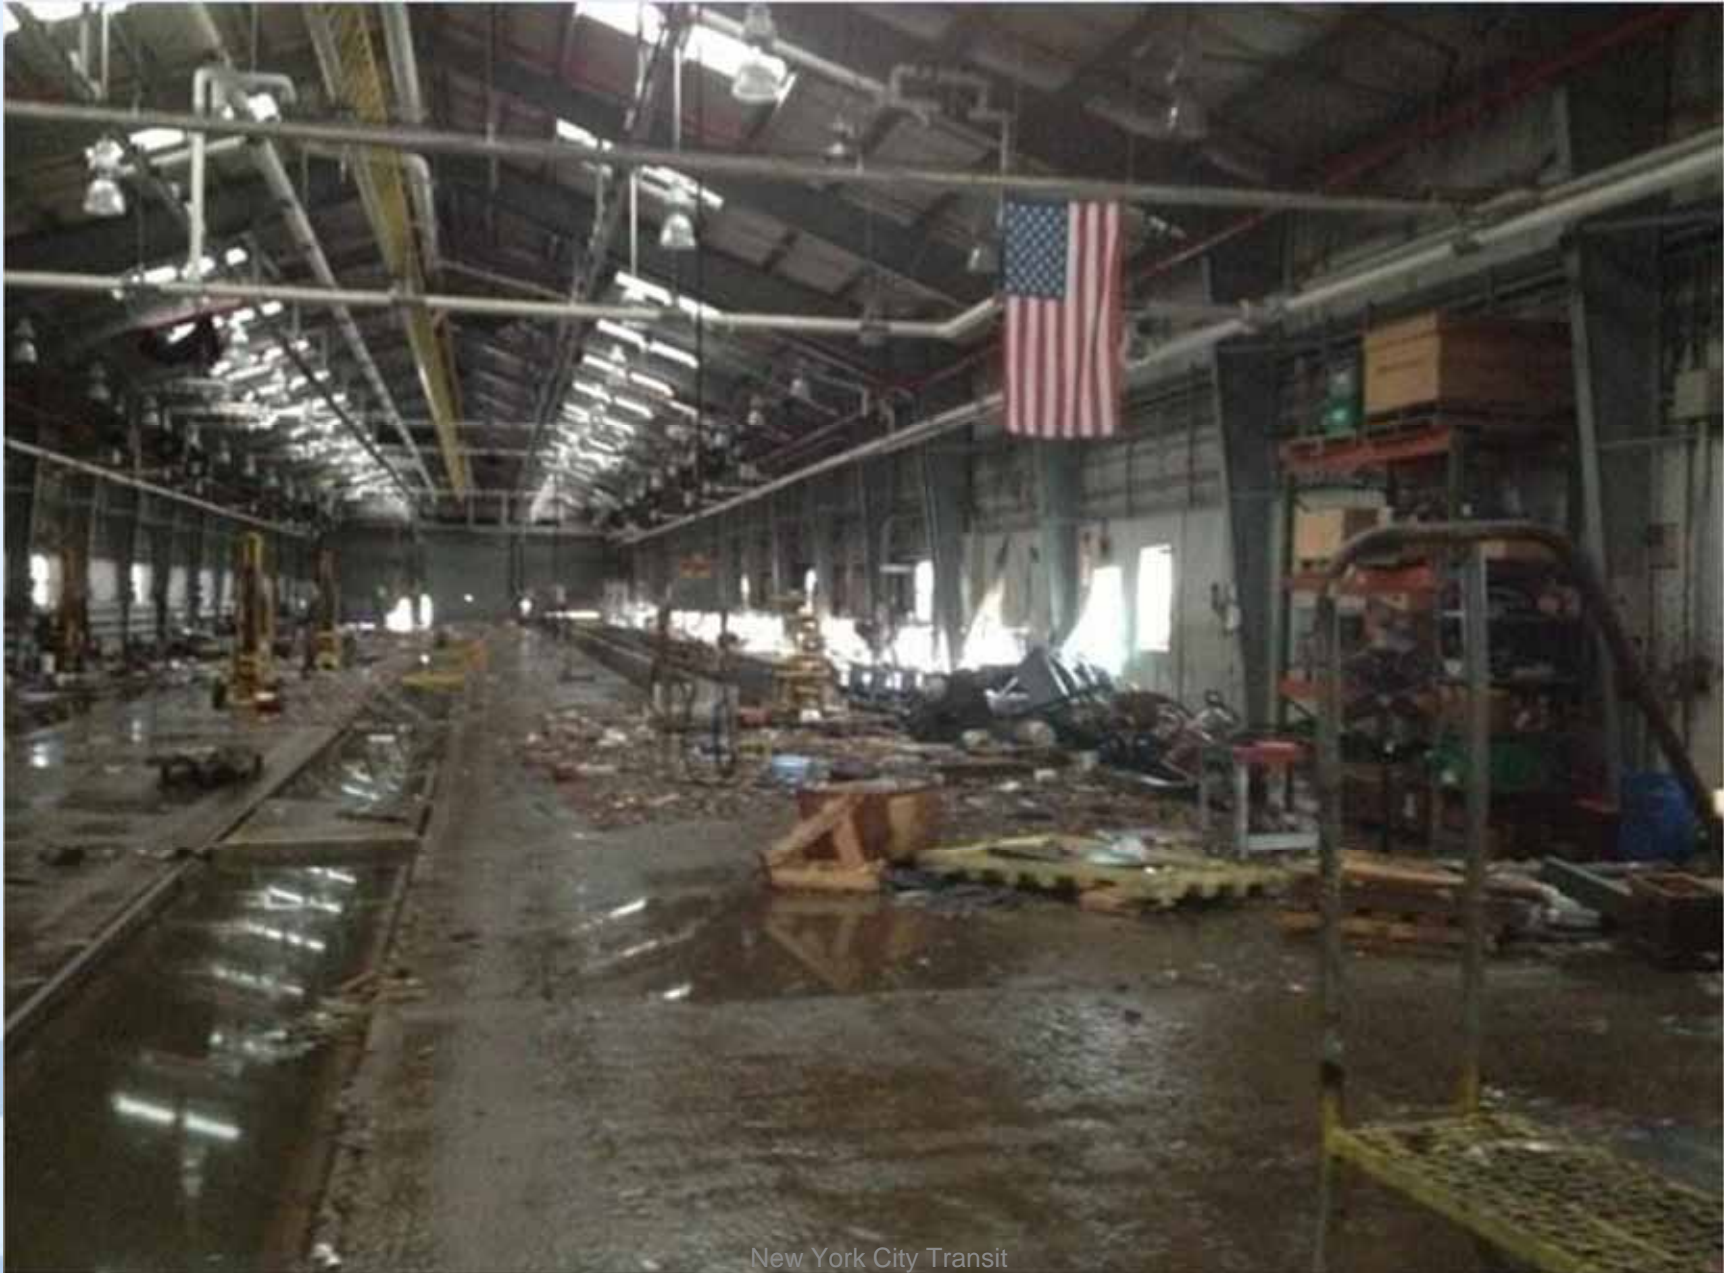
## Flooded Staten Island Railway shop

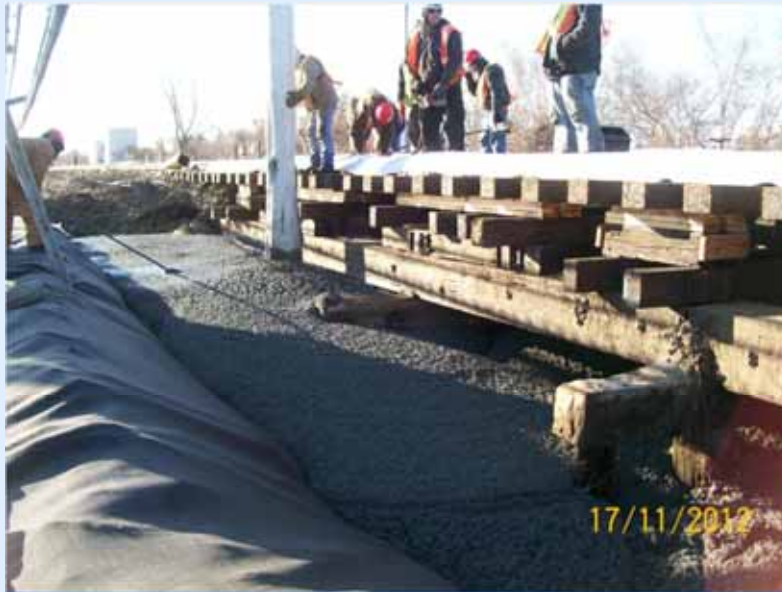
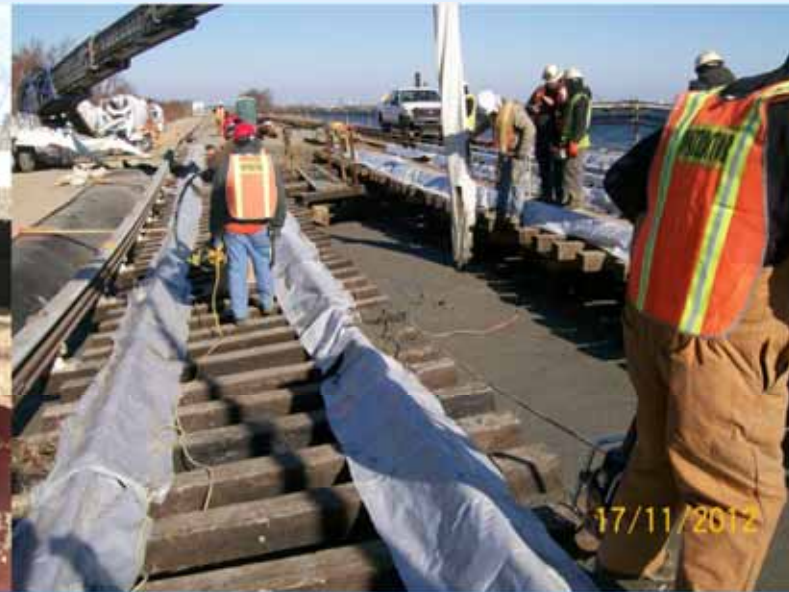
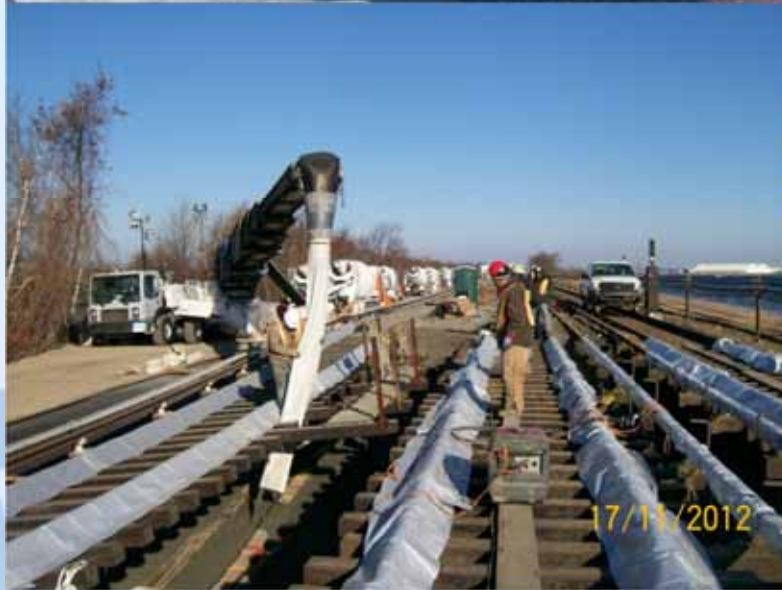
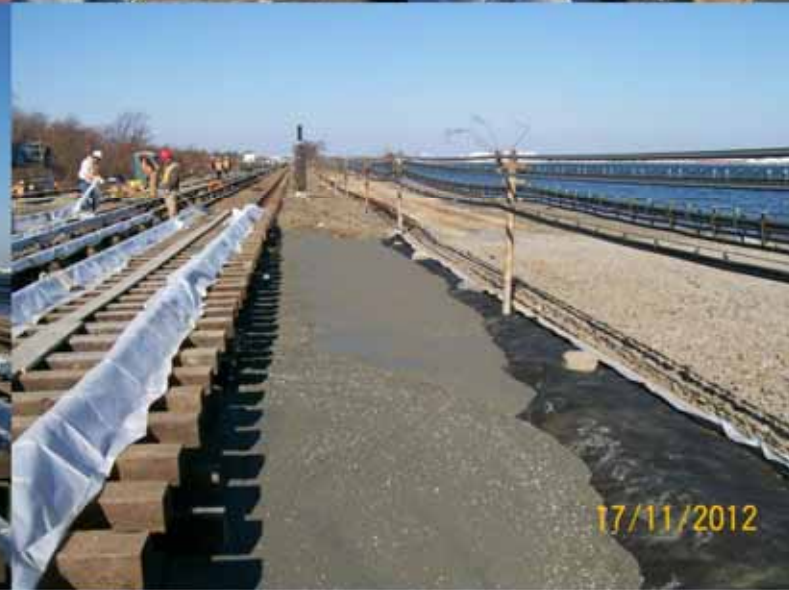
## Reconstruction work - Rockaways

- Work underway to restore washed out track sections over Jamaica Bay
- Work underway to assess and repair signal system at Rockaway Park
- **H** shuttle operating on peninsula with bus shuttle connection to Howard Beach

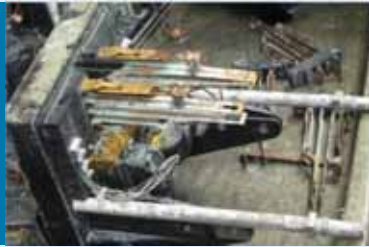
### Corrosion

- Metallic components that were exposed to salt water will experience accelerated corrosion
- Particularly problematic for electro-mechanical and electronic systems
- Long term deterioration of huge number of small gauge electrical connections

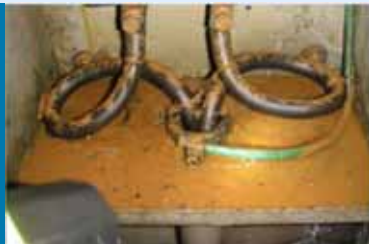
### Trash / sediment ingress and water damage

- Despite extensive clean up efforts, system has absorbed more trash and sediment that can cause track fires, foul drains etc
- Useful life of some system elements reduced due to water submersion, eg cloth cable sheathings
