New Haven Line Derailment/Sideswipe

May 17, 2013

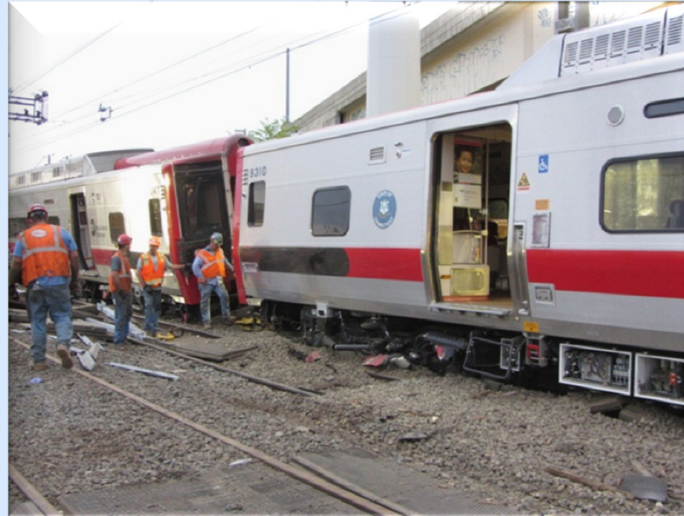
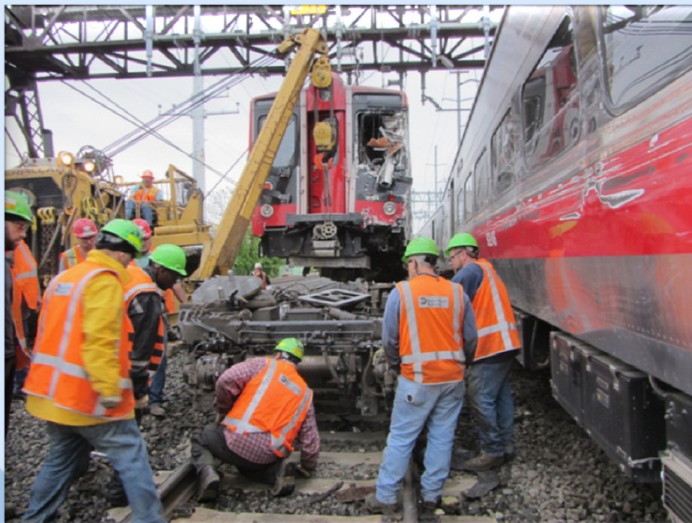
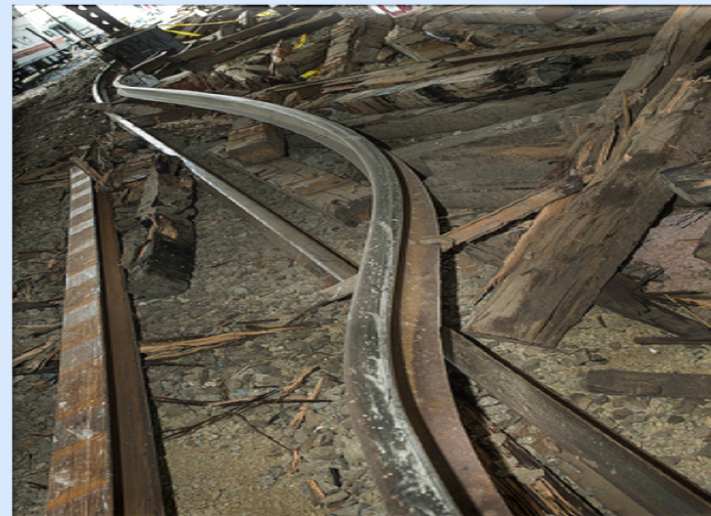
- Two tracks extensively damaged, including the catenary and signal systems. Track damage required the total reconstruction of approximately 2,000 feet of railroad infrastructure.
- Of the 16 cars involved in the incident, 10 cars remain out of service.

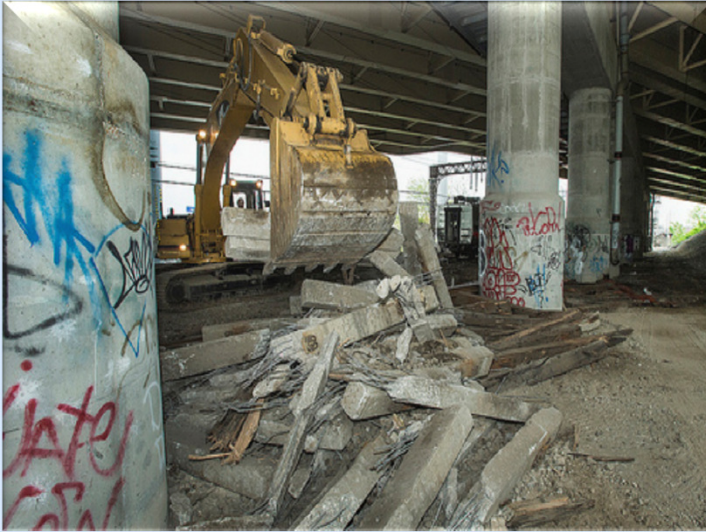
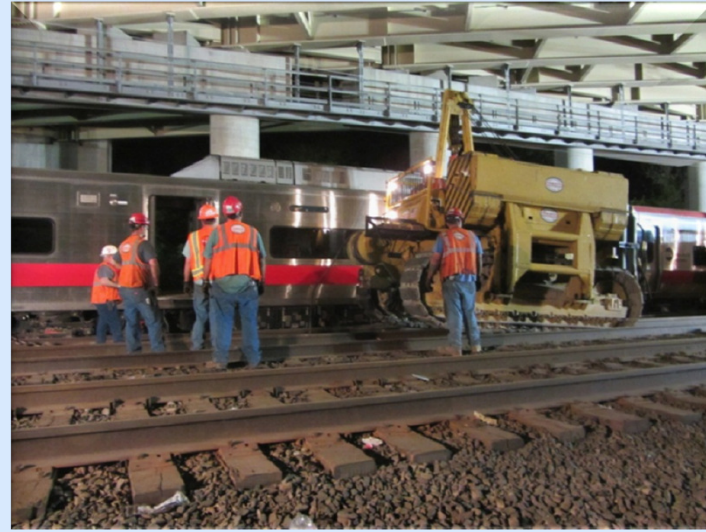
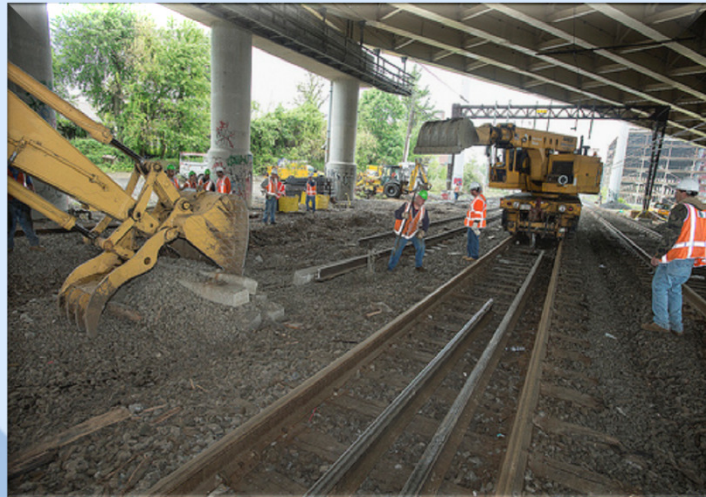
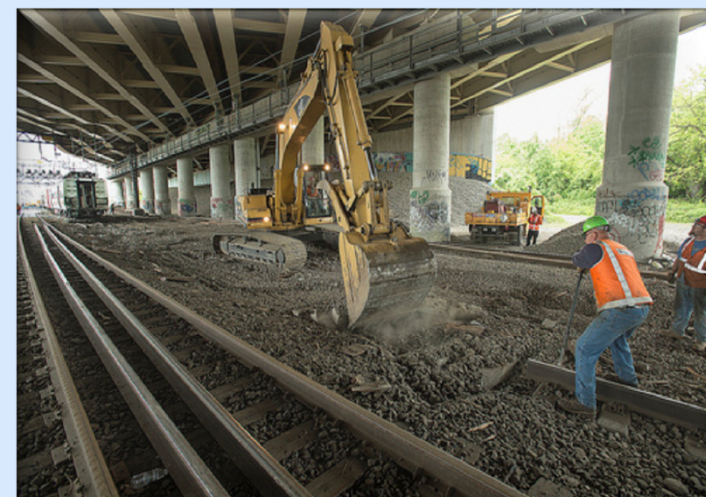
- Rebuilding the right-of-way infrastructure
 - Extensive work required; originally estimated to take as long as a week
 - Hundreds of employees working around the clock
 - Clearing debris and removing all damaged equipment
 - Laying new ties and ballast; fastening the rail to the ties
 - Replacing damaged overhead catenary wires and support structure.
 - Reconnecting to a nearby substation
 - Installing the wiring and components to reactivate the signal system
 - Testing all critical components
 - All signal testing was observed by the NTSB and FRA
 - Test trains were operated
 - Specialized equipment was used to perform additional testing
 - Tracks were restored to service with a temporary speed restriction (30 mph)
